**Newsflash - 2016 06****20 April 2016**

## Single Phase Cutout - Crutch Cover

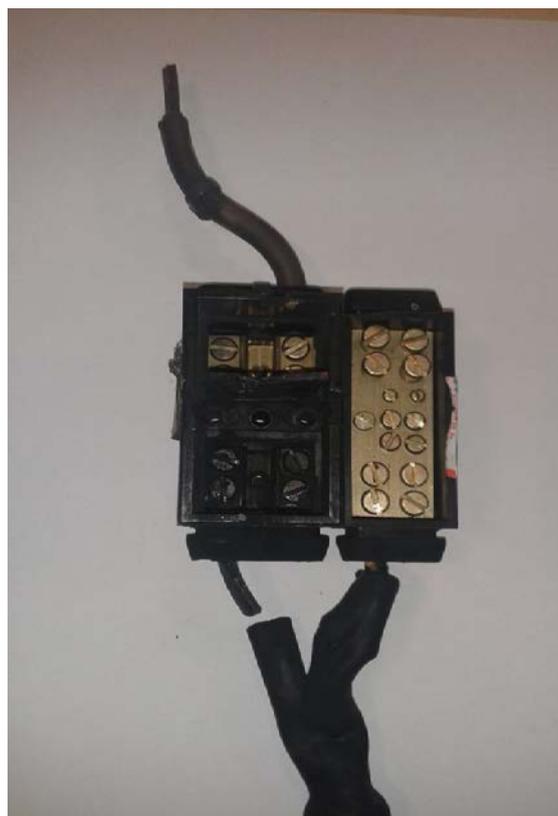
The incident has highlighted a cable make off procedure that utilises a PVC crutch shroud to replace the traditional cut-out base supplied with the unit (see example pictured). This type of crutch termination is utilised where there are access restrictions making the standard cut-out base difficult to fit. This alternative method of terminating a service cable due to access restrictions has been used in place of the supplied covers. The preformed PVC crutch shroud slides over the termination prior to it being connected and is a loose fit over the crutch of the cable.

All Northern Powergrid cut-outs are supplied with a plastic cover which should be installed over the incoming cable and crutch termination as they enter the terminations of the cut-out to prevent unauthorised access or inadvertent contact.

In this particular incident, if the supplied crutch cover had been used the flash would have been enclosed and the exposure of the meter operative to the resultant flash would have been significantly reduced.

**The use of the pre-formed PVC crutch cover is no longer the accepted practice to make off cable terminations and is no longer trained at our training schools. However, some units may still be available in local stores and some may still be out in the field, those should be removed from service. In the unlikely event the supplied crutch cover cannot be installed you should seek advice from your manager.**
