Excavation Service Partner Operative Injury

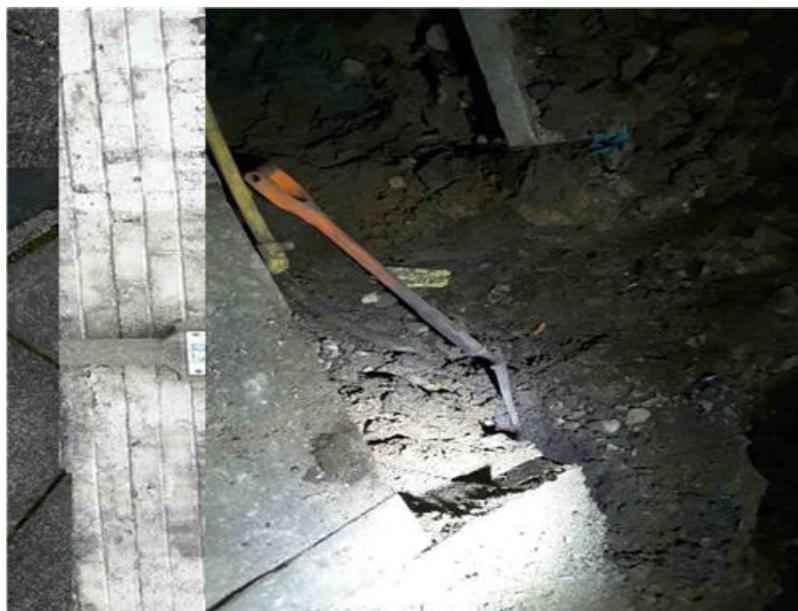
Whilst carrying out excavation work using a mini-excavator to assist with the identification and repair of a cable fault the team encountered an obstruction (a street lighting duct). An operative from the excavation team then entered the excavation and on moving the duct with an insulated shovel caused the Low Voltage (LV) cable directly under the duct to fail. The operative sustained superficial burns to his face.

- **PSSI 12 “Low Voltage Apparatus”** (updated) states “*The **Authorised Person** in charge of the work shall ensure that all personnel involved in the location and repair of faulty or damaged cables are briefed on the fault conditions and intended approach to work. All personnel shall be appropriately supervised. This is particularly important for excavation teams*”.

- After the position of all SPEN cables and other services have been established, mini-excavators may be used where the risk assessment identifies that this would reduce the risks to personnel while excavating, for example during excavations adjacent to LV fault location positions.

- Significant hazards and control measures that have been recorded on SPEN and the Excavating Contracting Service Partner’s risk assessments shall be shared and both parties shall sign onto each others assessment.

- Never step onto or put unnecessary strain on un-supported cables in an excavation.
- Always be aware of the risk of disturbing latent cable damage when excavating.

- Flame retardant outer clothing is worn correctly;
- Hands are protected by **Approved** gloves that are appropriate to the task. Consideration shall be given to the performance of the glove under electrical arc e.g. gloves shall not be of a type where the material from which they are made would melt onto the skin;
- Appropriate face and/or eye protection is worn.
