SHE ALERT

LIVE HV CABLE OPENED IN ERROR

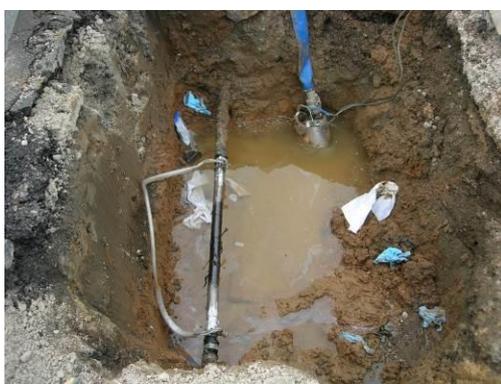
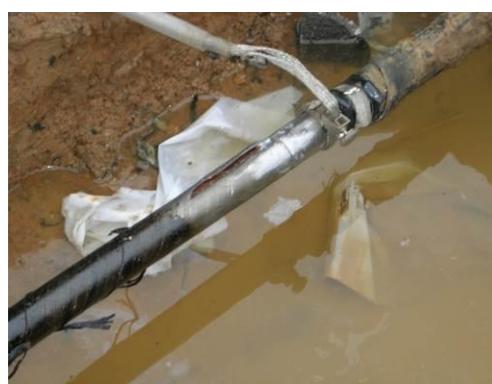
While preparing for a new low voltage connection a Jointer incorrectly opened a live high voltage cable. The work pack included copies of plans that showed the correct cable to be worked on and other high and low voltage cables in the immediate vicinity. There was only one cable exposed in the joint hole.

As the work progressed the jointer realised that the cable was not what he had expected and immediately stopped work and contacted his Supervisor.

Due to the different cable construction materials, there is a risk that the cable type and/or voltage may be mistaken and work started in error. The guidance for identifying LV cables recommends having plans on site for both HV and LV cables, locating ALL the cables in the immediate vicinity and positively identifying the cable as LV before work commences.

- On site physically trace out all cables indicated on plans within the work vicinity.
- Confirm that all cables in the immediate vicinity have been exposed
- Ensure that the cable to be worked is positively identified before work starts.
- If something doesn't look right, stop work and contact your Supervisor
