# SHE ALERT

## Failure of 3 phase Cut-out During Change

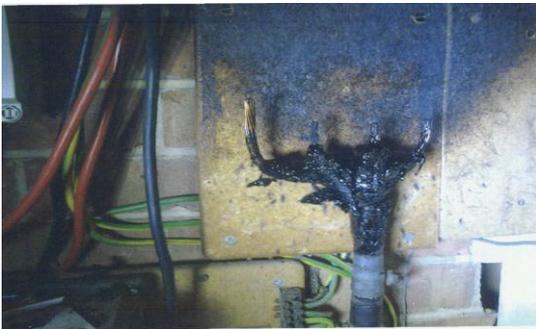
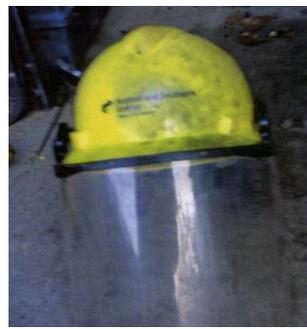
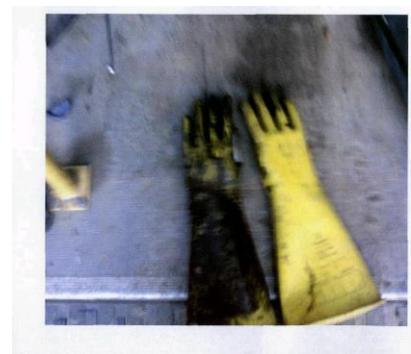
While attending a fault job, where the customer had reported a phase missing, it was decided that the cut-out assembly required replacement. The cut-out was of an older “Bakelite” design and during the work a flash over occurred.

The team carrying out the task consisted of an experienced and a newly qualified Joiner. As there was a clear area around the cut-out, they had made a decision that the newly qualified Joiner would complete the work to help him gain experience. A sound initial plan which was let down by the fact that the work was being undertaken with the incoming supply live. This was not in accordance with company policy or the Low Voltage Jointing Procedures.

- **Everyone**
  - Always follow the correct process & procedures for every task, - ask “what could go wrong” before, during and after each task, - don’t forget Brothers Keeper; look out for each other and keep each other safe
  - Ensure that the correct PPE is being worn for the task at hand
- **Supervisor**
  - Know & understand the hazards associated with the job & encourage the team to be wary and stop a job if they have SHE concerns or are unsure of task
- **Manager**
  - Continually emphasise that SHE standards will not be compromised just to get the job done, ensure effective and active practices are in place to audit, monitor & review understanding of process & procedure, lastly; know what’s happening on the ground and the standards that are being applied.

- MA-PS-019 LOW VOLTAGE JOINTING INSTRUCTIONS- SECTION 3 pg.5
