Reporting of obsolete cutouts with a fused neutral.

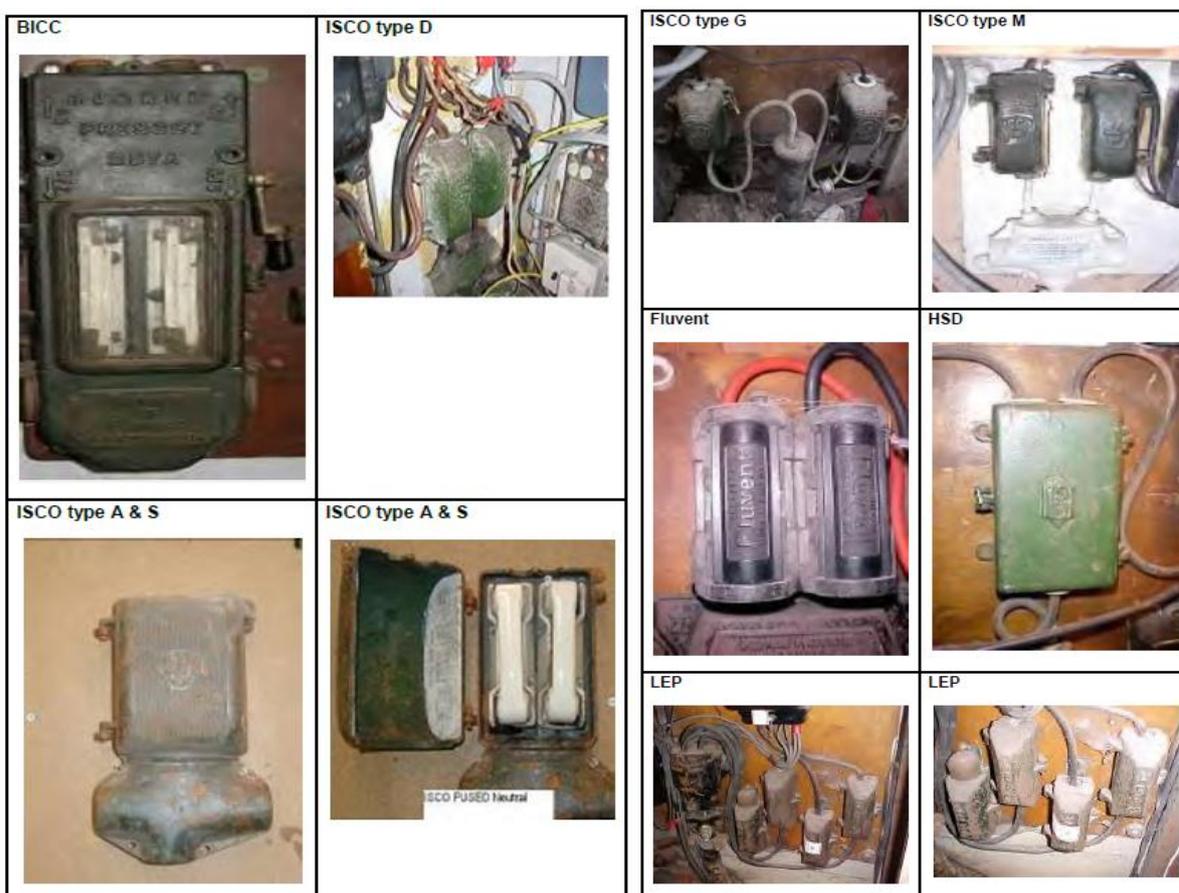
Cutouts with fused neutrals were prohibited when the Electricity Supply Regulations 1937 were issued and we have, through a programme of replacement, removed those that are known to us. The danger associated with a fused neutral arises when the fuse operates before the phase fuse leaving the customer's wiring live and potentially dangerous. Whilst the cut-out replacement programmes that have been in place for many years will have replace the majority of these obsolete cut-outs this information was never held on our asset records and therefore the only way to identify these are when an operative is on site. Although we expect the number of these cut-outs that remain in service to be extremely low, an operative recently attended a customer's premises and found a cut out with a fused neutral indicating there are still be some left in service.

Typical fused neutral cutouts.

This brief is a remind to ALL staff and contractors that come across cutouts with fused neutrals to report them for replacement, as a matter of urgency, using the 159 process (option 4). Reporting them using the 159 process will facilitate an OMS Task to be raised for the cut out to be replaced. Other than replacement of fuses no work should be undertaken on such cutouts.

Meter operators should report cutouts with fused neutrals through their own approved processes and data flows. It is important that each cut-out is promptly reported to enable replacement.
