SAFETY FAMILY IN ACTION

GS6 Goal Posts – Potential Oil Contamination

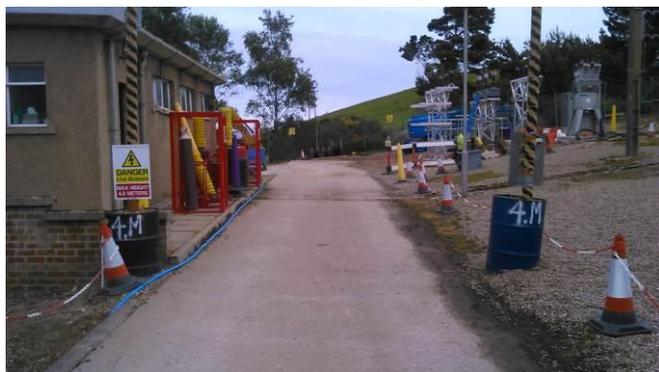
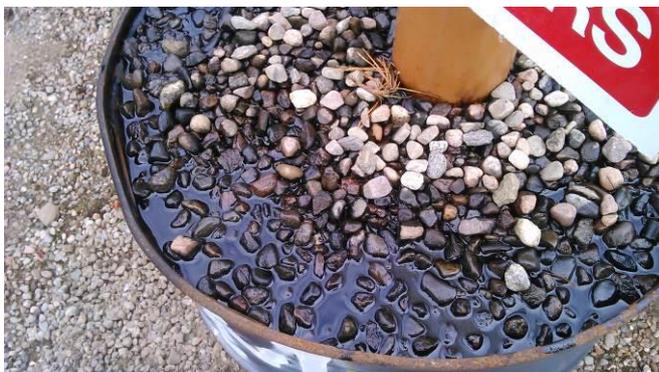
Old barrels filled with ballast that were being used to support GS6 Goal Posts contained residual oil which was brought to the barrel surface due to ingress build up of rain water.

As part of routine site inspection activities at Brora Sub Station a Site Supervisor noted oil sitting on the surface of stones being used for ballast in two old barrels that were being used to support GS6 Goal Posts that had been placed, within the sub-station as part of ongoing refurbishment works, on the approach to over head live busbars.

- Include the checking of (GS6) type barrier systems in the audit process, pay particular attention to recycled items
- Ensure that recycled items have been completely decontaminated before putting them to use.

- Re-using old barrels should not be carried out unless it can be proven that they are free from contaminants.
- If any doubt exists as whether you should re-use an item, consult your supervisor.
