Restriction on test plug use on ABB LV Board

A flashover occurred on the test connection facility on the ABB LV switchboard whilst an operator was carrying out testing associated with the disconnection of generator.

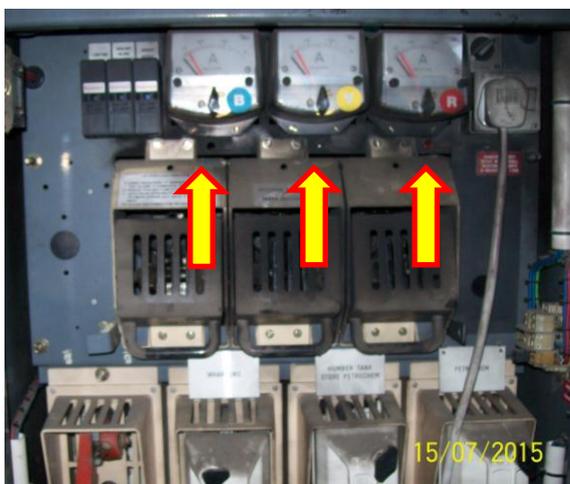
SLB4-F

The engineer was using the 4mm Banana plug test sockets on the LV board to obtain a voltage reference source when the flashover occurred. The engineer was wearing the appropriate LV PPE for the testing work and was uninjured.

This is the second instance where a flashover has occurred on an ABB LV board whilst the test plugs were being used. The cause of the failure has been attributed to the deterioration of the plastic insulation around the test socket where it is fixed to the earthed metal steelwork of the panel. The insulation appears to have become brittle and can break away when applying test leads at the socket. The test socket connects directly to the LV busbars via an unfused lead.

A programme is to be initiated to modify ABB LV boards with test sockets that have more robust insulation and have a fuse in the supply lead at the busbar connection point.

Until such time as these modifications have been carried out a restriction banning the use of these test sockets has been applied.
