Stay Rod Thread Issue

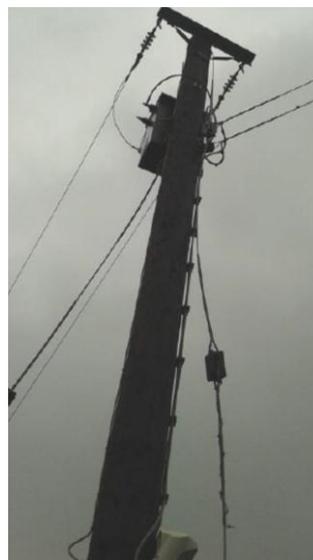
In the first incident, a linesman had made off the new stay. He was then removing the old stays when he was struck on the back of the helmet by the stay wire. Upon inspection, the stay barrel had come away from the rod and the rod's thread had been stripped.

In the second incident, the stay wire was made off, and it was the eye bolt/pin that came away under the tension, while the barrel remained on the rod.

Detached stay

- Prior to any work being carried on a line, the existing stays shall be inspected.
- Where existing stays with loose locking nuts are found, the nuts shall be tightened and secured.
- Prior to the installation of a new stay rod, the threads of the rod shall be inspected to ensure that the nuts fit the rod properly.
- When the work is complete, a final check of the completed stays shall be made.

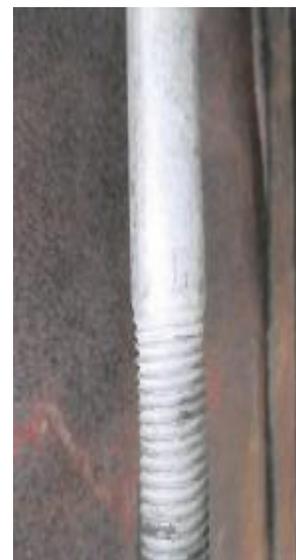
There have been two separate incidents where poor manufacturing has resulted in the threads of stay rods being stripped when being made off to final tension.

These rods were manufactured in 2012. Since then, the manufacturer has invested in new machinery and has tightened up their Quality Assurance (QA) processes.

Narrow thread on a stay rod

Going forward, stay rods manufactured by the new machinery will not have this problem.

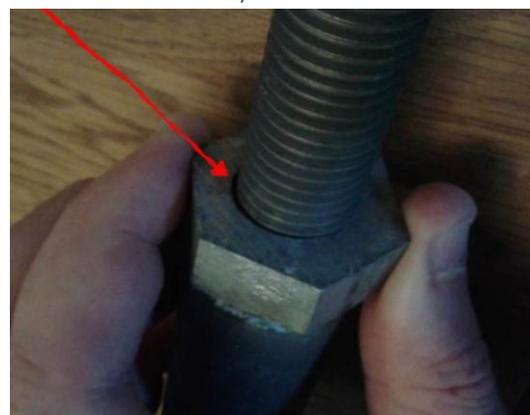
An inspection of 324 poles on 25 different circuits showed 90 poles exhibiting at least one loose locking nut on the stays and 7 loose stays. An inspection of 18 stays in another location, identified 8 with loose locking nuts.

Improved QA process by the manufacturer, together with new threading machinery, has rectified this problem.

"Loose" fit of nuts on stay rods
