Contractor Incident at Naylors Road Substation

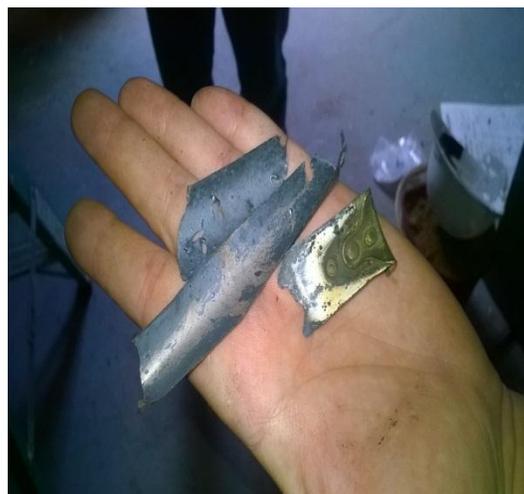
The steel tape recoil mechanism had failed and approximately 10 inches of tape was left extended from the body of the unit when placed on top of the transformer.

Extended steel tape measure

- Authorised staff to be reminded of the possibility of exposed live conductors behind the protective cover to the 11kV/415V transformer LV connections.
- All exposed live equipment adjacent to the work area shall be shrouded to prevent inadvertent contact with persons or objects.
- Only approved insulated tools shall be used when working adjacent to live equipment.
- A steel retractable measuring tape is not an approved tool and must not be used. The approved tool for measuring purposes is a 3 metre non conductive measuring tape, stock code 30982608.

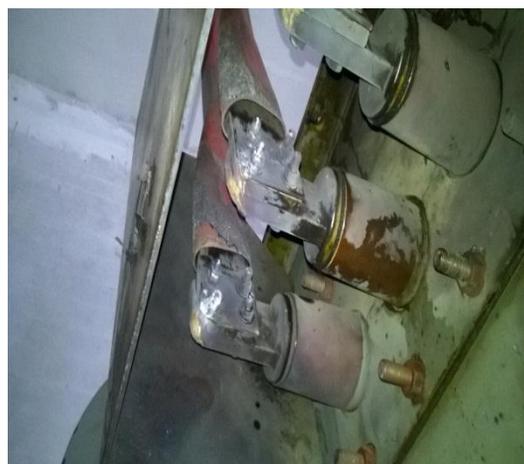
Following installation of plastic conduit to the wall adjacent to the transformer and whilst descending a ladder, the electrician`s mate knocked the extended steel tape which caused the body of the unit to slide across the lid and fall behind the protective cover onto the transformer live LV terminals

Damage caused to terminals during flashover
