SHE ALERT

Tree falls over road across Low Voltage line

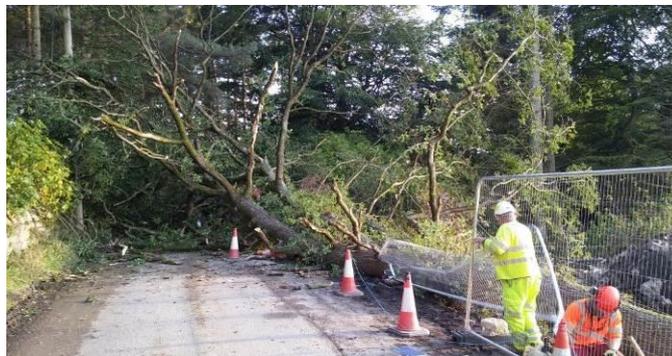
A Tree Cutting team was sent to fell trees in proximity to a low voltage line. The team attempted to fell a large (25m) Oak tree using the two rope method. Owing to the poor quality of the felling cut, the tree fell at 90 degrees to the intended direction, causing it to fall across a minor road and hit a pole, bringing the wires down.

- Prior to 2 rope felling taking place, a Supervisor must approve the works. The operation must be witnessed by the Supervisor or the approval noted on the Risk Assessment.
- The weight bias and wind conditions must be assessed. If the site conditions have changed following the initial site visit then the team must reassess the site and the associated hazards.
- If the job can not be carried out safely then a more suitable alternative to 2 rope felling should be implemented.
- The primary function of the 2 ropes is to ensure that, if the felling operation goes wrong, then there is no possibility that the tree could fall onto conductors or any other electrical apparatus. One of the ropes can be used to assist the felling but only if there is a locking mechanism to prevent the rope slipping backwards.
