SHE ALERT

BLUE ELECTRICITY CABLES LOCATED WITHIN ANOTHER DNO NETWORK IN LOWESTOFT

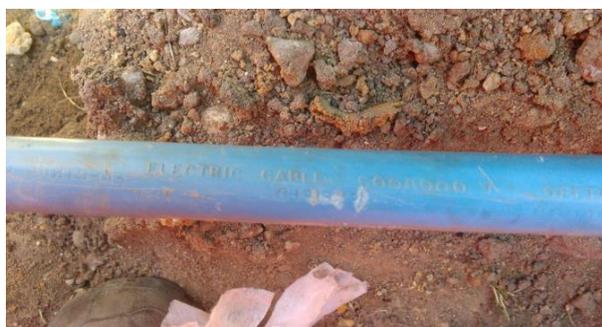
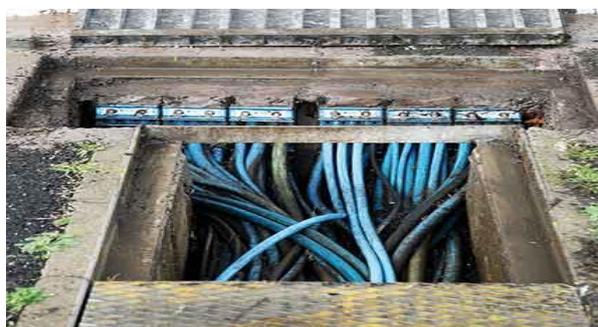
A team of operatives working within another DNO have uncovered what they initially thought to be a standard blue water pipe. The team assumed the supposed water main was therefore in a position close to where they also expected to find electric cables. Upon closer inspection and using suitable cable detection equipment and associated “As Built” drawings, the team however confirmed that the assumed blue water pipe was indeed a 600/1000 volt Electric Cable.

- Ensure you lead by example and set the standards for your team, confirm their vigilance at all times.
- Challenge your teams on their understanding of cable identification processes and procedures.
- Remind your teams to update drawings in our GIS management system.
- If appropriate, look to remove any cables that are not to current installation standards or approved code of practices.

- When on site physically trace out and confirm all cables indicated on plans.
- Confirm all services & cables in the immediate vicinity have been adequately exposed and identified.
- Ensure that the cable to be worked on is positively identified before work starts.
- If something doesn't look right, stop work and contact your Supervisor.
