SAFETY FAMILY IN ACTION

HEIGHT RESTRICTORS ON EXCAVATORS

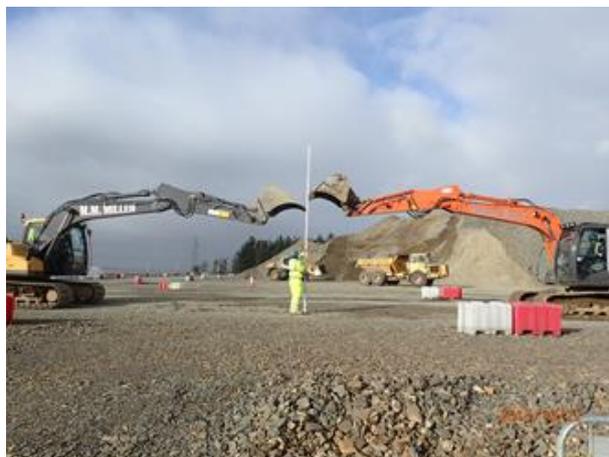
During this check, the same procedure was taken for all excavators fitted with height restrictors on site and it was evident on one excavator that when following the procedure above the top of the excavator dipper arm was approximately 400mm greater than the height set on the restrictor when the bucket of the excavator was lowered to the ground.

Note the image to the right shows both machines set at 4m height: the machine on the left is a Volvo EC140DL and the machine on the right is a Hitachi 130 Lcn.

Notice the difference in bucket heights.

The Volvo (left hand side) is governed by the top of the dipper arm (when fully extended) where the Hitachi (right hand side) is governed by the top/back of the bucket. The consequence of this could be a potential breach of the safety clearance by approximately 300-400mm.

When setting to work any excavator or item of plant in proximity to live OHL, as well as seeking advice from the OHL owner and implementing the requirements of GS6, all plant and equipment with the potential to breach the safety distance that require height restrictors to be in used should be checked in all configurations to ensure the maximum allowable height cannot be breached once the height restrictor has been engaged. All excavators and items of plant where height restrictors are to be used should be checked to ensure they are set correctly.

If in doubt **STOP** and seek further guidance, Remember whilst it is good practice to limit the working height of equipment whilst working near OHL's, we should always check whether or not we need to be working near live equipment and where possible limit the size of the equipment used to reduce the risk.
