Line Patrol Injury

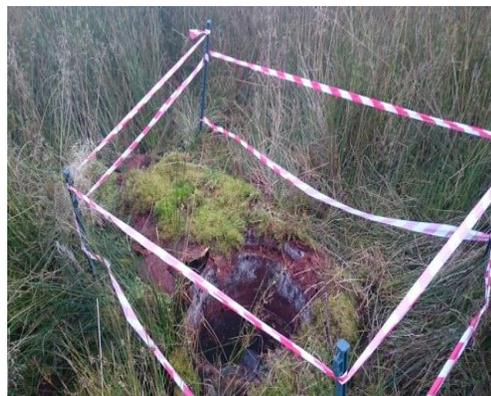
During an overhead line patrol on 14th October 2015, an overhead line surveyor, working for one of our Service Partners, suffered a serious injury when a wooden board that had been used to cover a manhole collapsed when he stepped on it. The board was in poor condition and was completely overgrown with grass and moss. The surveyor struck his knee on the ceramic edge of the well as his leg fell into it.

The well was on Forestry Commission land and was unmarked. There are a number of similar such wells across the country and staff should be vigilant whenever walking across rough terrain.

Well once uncovered

- All staff required to cross rough terrain to be alerted to this incident and the danger of unmarked wells.
- All managers and supervisors with staff who work alone to read “Lone Working” procedure [SMS-11-021](#) and implement requirements to protect lone workers.
- A risk assessment, whether generic or a START site specific, must identify control measures to monitor and communicate with lone workers.
- Means of communication should be considered particularly if mobile phone signal may be poor.
