Rotten Pole fell in close proximity to a team operating a mini digger.

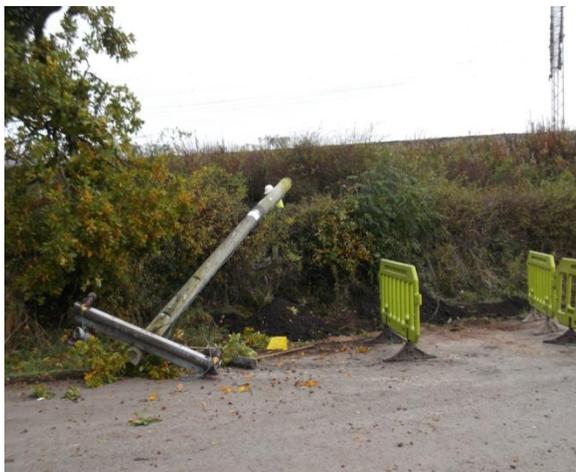
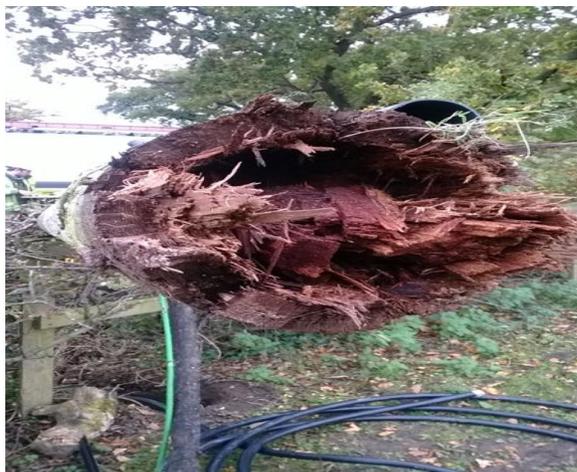
Following work that was being undertaken to reinstate an open trench, a terminal pole with live conductors and cable attached, fell within close proximity to the working party.

An investigation has taken place which identified that the pole had been inspected and classified as HI-5 in August 2013. The pole was also identified during a site visit as rotten by the Project Manager and was due to be replaced as part of the Connections Project.

The investigation has also identified that the stay rod had been damaged previously.

The investigation team believe there was inadvertent contact between the mini-digger and the stay wire, which, due to the poor condition of the pole has resulted in the pole failing and falling to ground.

- Where any excavation work is planned, using plant or machinery, near to or within close proximity to a wood pole or stay rod, carry out a visual inspection before starting. If you have any doubts, concerns or issues about the condition of either the pole or stay rod, **STOP** and contact your Team Leader or Supervisor.

- The Health Index (HI) is used to identify the residual strength of a pole. If you / your team are not familiar with the Health Index document, please use the attached to review with your team ([QUAL-12-288](#)).
