Safety Advice 01-2014 (UK) (Jan) (Generation) Grinder, Loose Clothing, Strangulation

Fatality due to Strangulation – External to GDF Suez Group

Bulletin No	Date	Severity	Potential	Likelihood of reoccurrence
FOGAP UK 062	05/12/2013	FATALITY	FATALITY	POSSIBLE

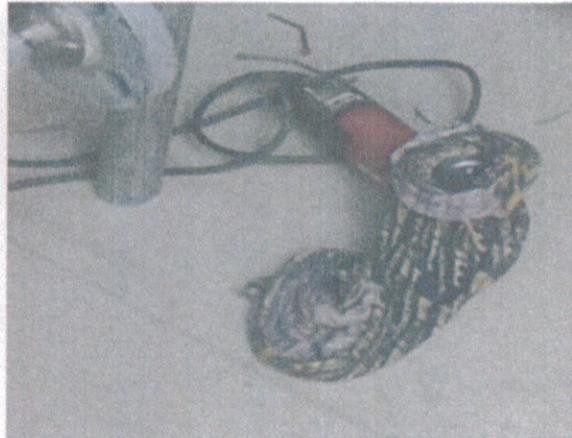
- A contractor worker was working to eliminate rust on a 1 inch piping with a power wire brush before painting.
- The victim was wearing a neck muff to keep warm from cold weather.
- The neck muff rolled into the power wire brush and the victim was suffocated by being strangled his respiratory tract by the muff around the neck

Loose clothing been worn whilst using open / unguarded rotating equipment.

Awareness of the potential hazards from the IP. Lack of or poor supervision. Poor working practices

Hand held angle grinder with wire wheel attachment and part of entangled garment

Ensure that the basic details of this tragic incident are communicated to all relevant employees. This is a timely reminder of the hazards associated with using rotating equipment and the potential for entanglement with parts of external clothing especially cords from coats and hooded shirts, scarves etc.

Supervision to be vigilant during periods of cold weather to try to identify individuals who may be wearing inappropriate items whilst operating any form of work equipment.

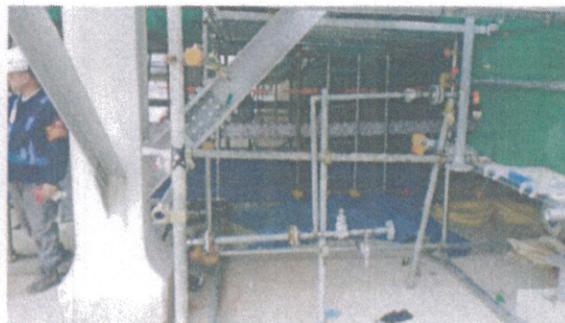
Work location of the fatal incident
