SHE ALERT

Damage to HV cables whilst excavating

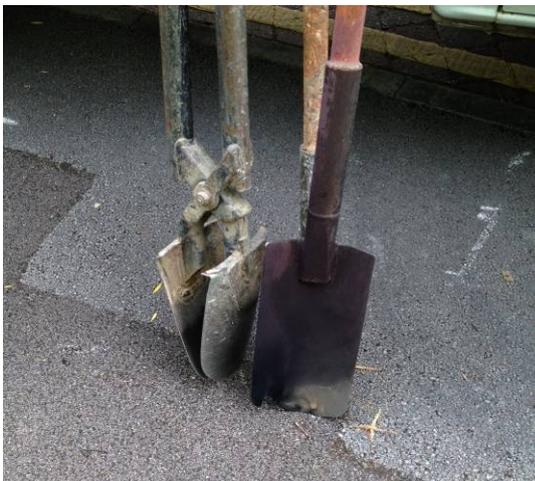
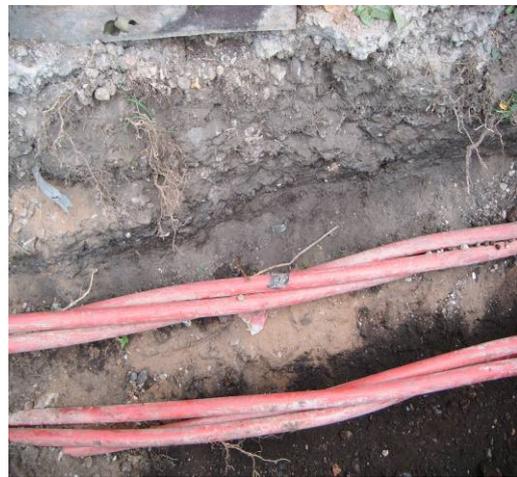
On 3 July 2014 a HV cable was struck by operatives working for a sub-contractor in Nottingham. The cables had been identified on the utility plans and had been marked on the pavement. The operatives were excavating with the use of insulated hand tools and a flashover occurred when the cable was hit. There were no injuries however there was potential for this incident to be much worse.

This incident could easily have been avoided by improved care and utilising correct digging techniques

- Ensure safe digging techniques are utilised (HS(G)47 and WI-CG-LS-100) and do not rely on tape/sand/tiles as more often than not none of these are present.
- Ensure you scan and rescan at regular intervals (150mm) and expose cables in accordance with safe working practices (HS(G)47).
- Adhere to **C-S-M** Check drawings, Scan ground, Mark services prior to starting any excavation.

- If job is started and then put on hold, ensure that the risk are re-assessed prior to the job pack being re-issued and perform a new induction with updated stats.
- Take time to brief and confirm understanding of hazards identified.
- Supervise excavations where difficult conditions are identified.
- Avoid planning to excavate directly on top on LV and HV mains and identify using a slit trench.

- Obtain detailed information from site and if vague follow up as soon as more accurate information is available rather than pass opinion.
- Use Site Engagements to coach the team on safe excavating techniques and the Safety Family Culture.
