Date	13 March 2014	Ref	HSEQB080314-2
-------------	---------------	------------	---------------

Youngman BoSS X3 Pop-Ups

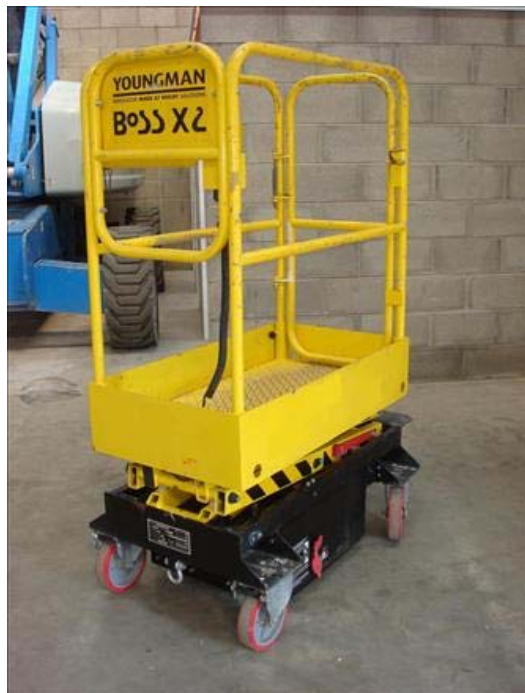
There has been a recent industry incident where a Pop-Up platform failed to stop elevating even after the operator released the controls and pressed the emergency stop button. The platform continued to rise through a ceiling causing part of the ceiling to collapse which injured a colleague.

The operator had been trained and was experienced in the use of the equipment. The operator had also carried out a full daily pre-use check that included testing of the emergency stops.

Youngman have issued a product advice notice regarding this type of machine and believe that the most probable cause is excess heat at the contactor points, possibly attributed to excess current being drawn as a result of a drop in battery charge.

Mandatory Action Required

Quarantine any Youngman BoSS X3 Pop-Ups, note the serial number and contact the supplier to establish if the unit requires remedial action.

If similar types of unit are in use produced by another manufacturer sites should contact the supplier to confirm that the supplied equipment cannot suffer the same type of failure.

When operating this type of equipment users should:

Complete a full Pre-Use Inspection which should include the Emergency Stop buttons
Maintain the battery charge above 20% to prevent a potential voltage drop.
