**Health, Safety & Environment Alert
Not Protectively Marked**

EFS-79

Ampy Meters - Cracked Covers

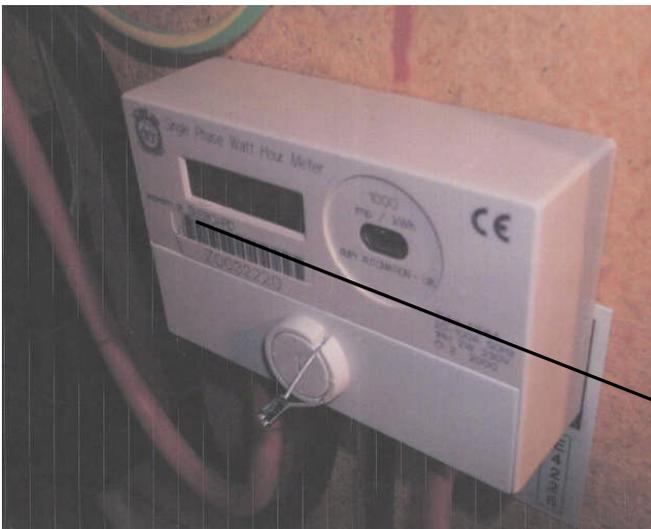
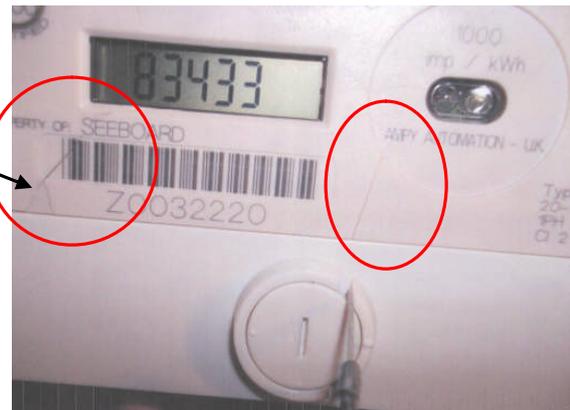
Following recent visits to customer premises it has been discovered the front plastic covers, which enclose the main body of the meter, had become brittle. If disturbed these covers may break with the risk of exposing live terminals.

Manufacturer: **Ampy**
Type: **5196 A/D**
Manufacturer date: **2000**

Hairline cracks on the cover during inspection

If you should encounter this type of meter, approach with caution and do not touch before de-energising.

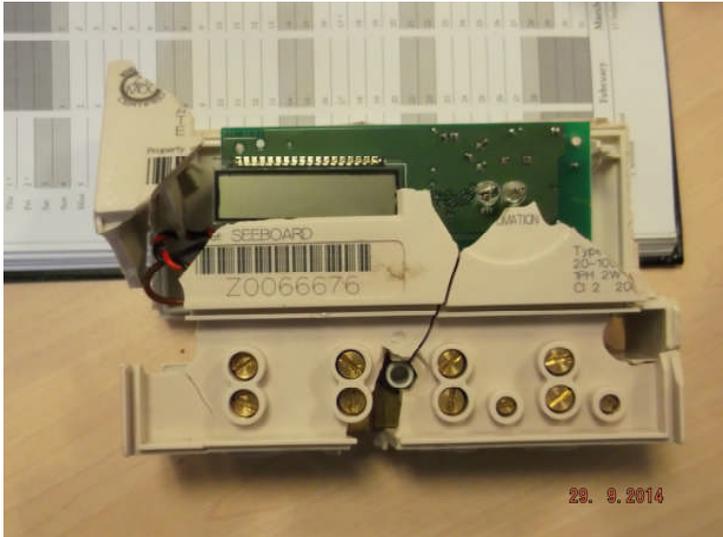
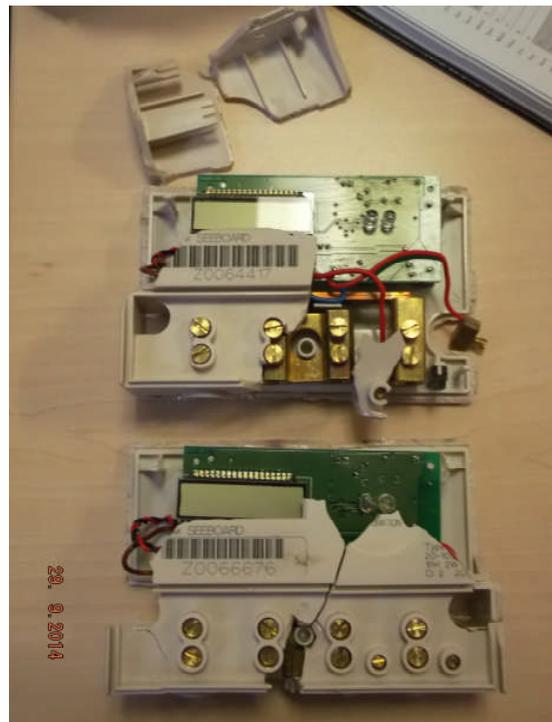
On removal, the meters are extremely fragile and the covers can break

The cause has yet to be determined but the manufacturers have been notified.
