Urgent Attention Safety Bulletin

Significant Potential Incident

11 July 2017

Incident summary

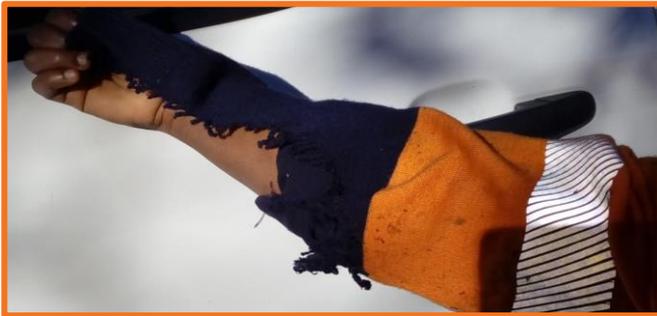
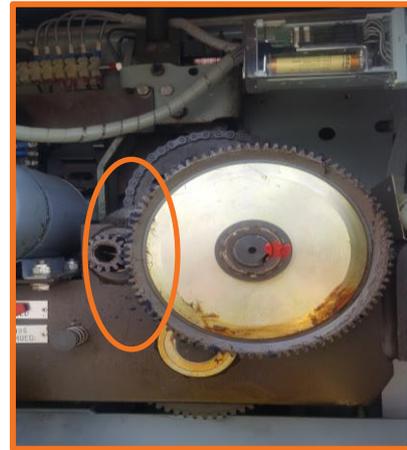
On 07 July 2017, one of our colleagues was reaching inside a circuit breaker mechanical box to apply test leads, when the sleeve of their jumper became entangled in the components as they were operating.

The individual received minor bruising to their wrist, however they did not require medical treatment.

- In order to complete the timing test, the individual was required to reach inside the mechanical box to hold the test leads in place, while a second person operated the circuit breaker on a control panel below. This meant that their arm was in close proximity to the moving components.
- The test is a frequently performed practice.
- The moving components must be operational and therefore cannot be isolated while the testing is taking place.

- Until further notice the timing test on circuit breakers is to cease.
- All Western Power employees have the right to stop work immediately if they believe it is unsafe to continue. This can be done by implementing a *Stop Work Authority*.
- When developing a Workplace Risk Assessment Plan for a task, it is important to identify all mechanical hazards and ensure appropriate controls are put in place.
