Occupational Health & Safety Bulletin

ESAA 08/2003

Bulletin No. 2003/?

- Employee's pole strap became unclipped causing employee to fall to the ground

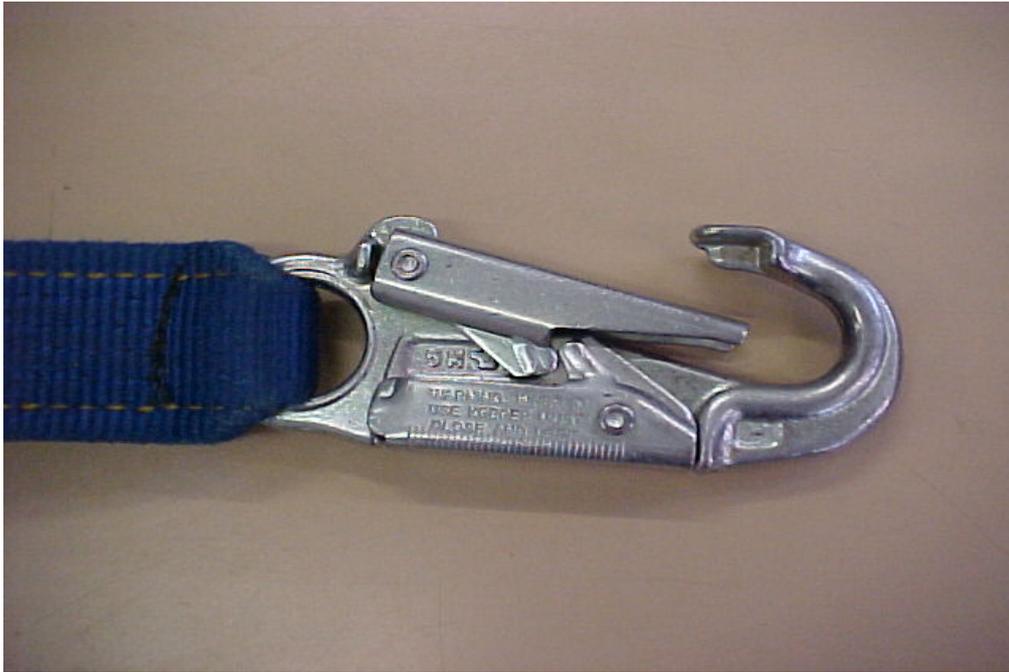
Photograph 1

The above pole strap was selected at random to provide a comparison with the strap involved in the accident. It was discovered during the investigation that the locking catch could remain in the open position. While this is most unlikely with movement and vibration, staff should be aware that this can happen and ensure that the locking catch is always closed.

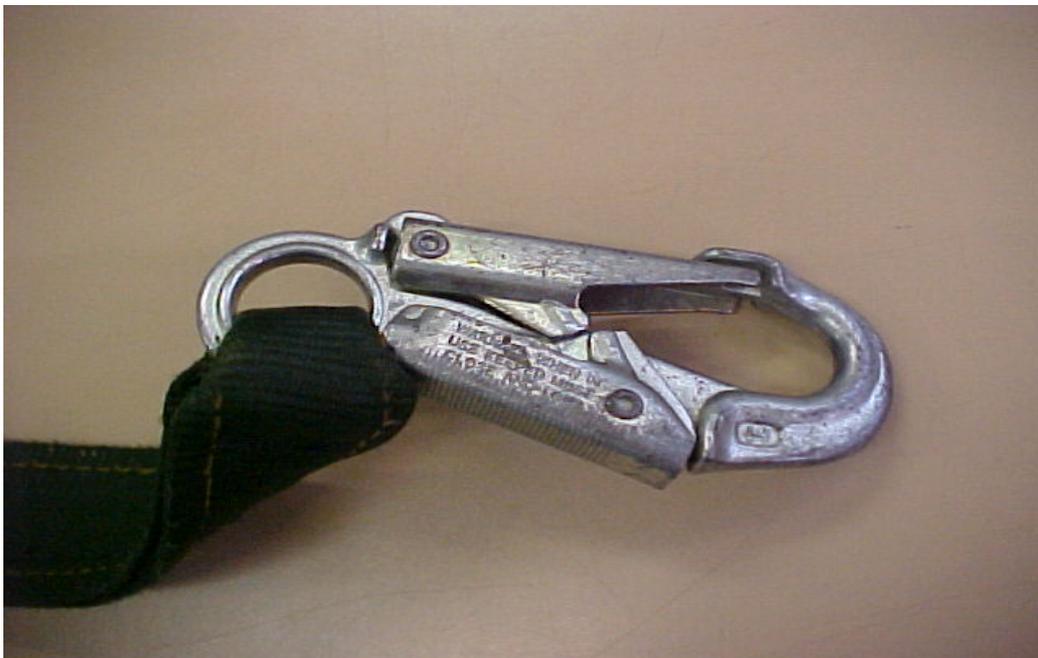
Photograph 2

This photograph illustrates that a twisted belt can force the locking mechanism down allowing the locking catch to be opened. Opening of the locking catch can also be caused by tools worn on the belt, pole steps on the pole or any other attachments to the pole. Again, while this is most unlikely to occur, it should be recognised that the pole strap can be distorted while moving around the pole and trapped by equipment attached to the pole. It should also be noted that even with tension on the strap, the location of the strap on the snap hook will be retained, with the locking catch rendered inoperative.

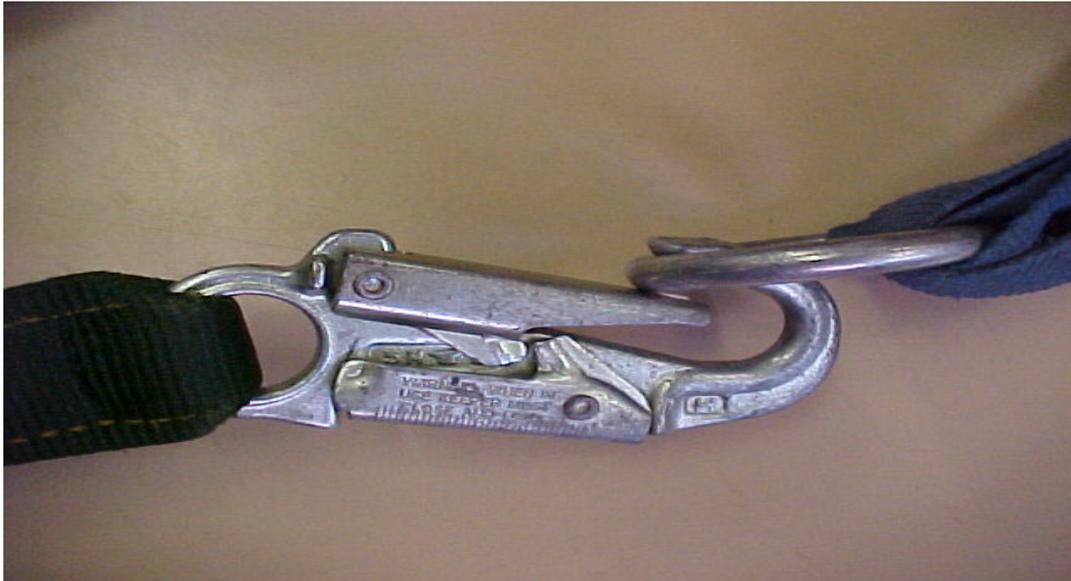
Photograph 3

Employees should ensure that when the “D” or ring is placed in the clip, that it should be fully in the hook with the safety catch closed. The above photograph shows that it is possible for the ring to catch on the safety catch locating bar and be held in that position by the safety catch. Considerable tension can then be placed on the strap and it will remain in this position without clicking into its proper location. When the tension is released from the strap, the ring will come free and release the strap.

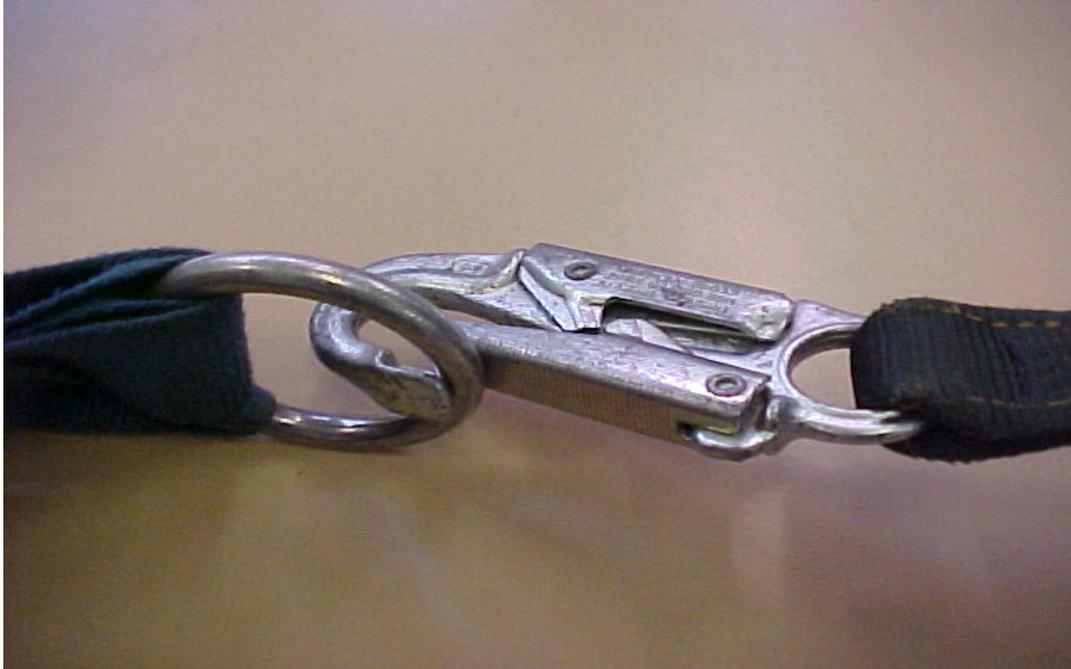
Photograph 4

This photograph shows the problem defined in photograph 3 from a different angle.

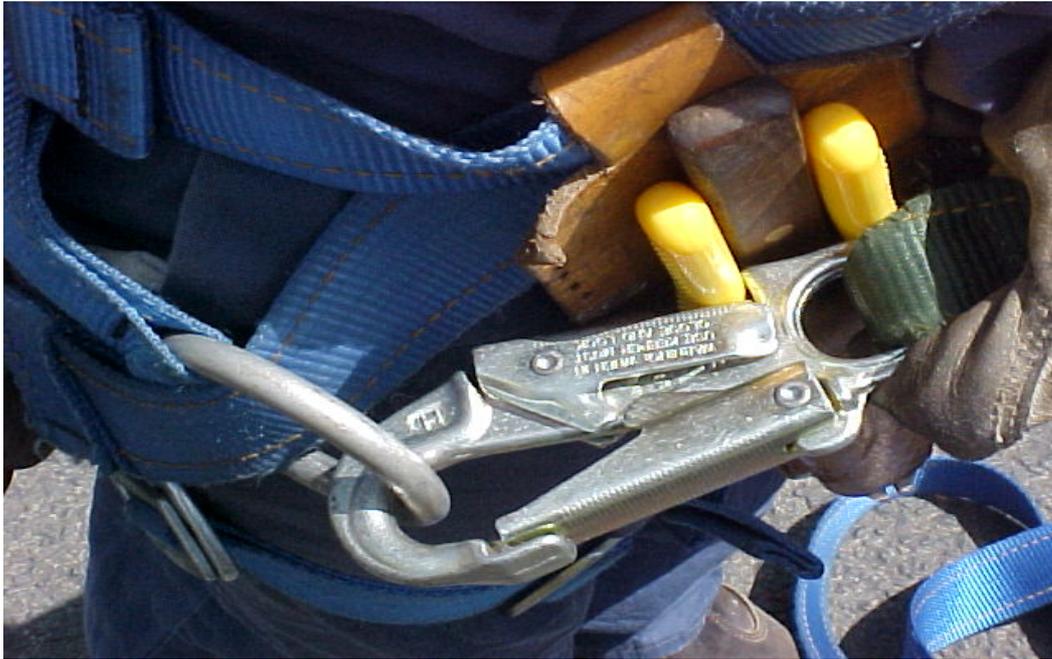
Photograph 5

This photograph shows the problems of not having the correct orientation of the locking catch to the body and also the inadvertent operation of the catch by tools worn on the belt. The locking catch should be on the outside of the pole strap and this will prevent tools from opening the locking catch. However, other objects such as pole steps can also cause operation of the locking catch if they are pressed against it.

While it is difficult to cause a double operation of the catches, it is possible that both catches could be compressed between two separate objects releasing the ring.

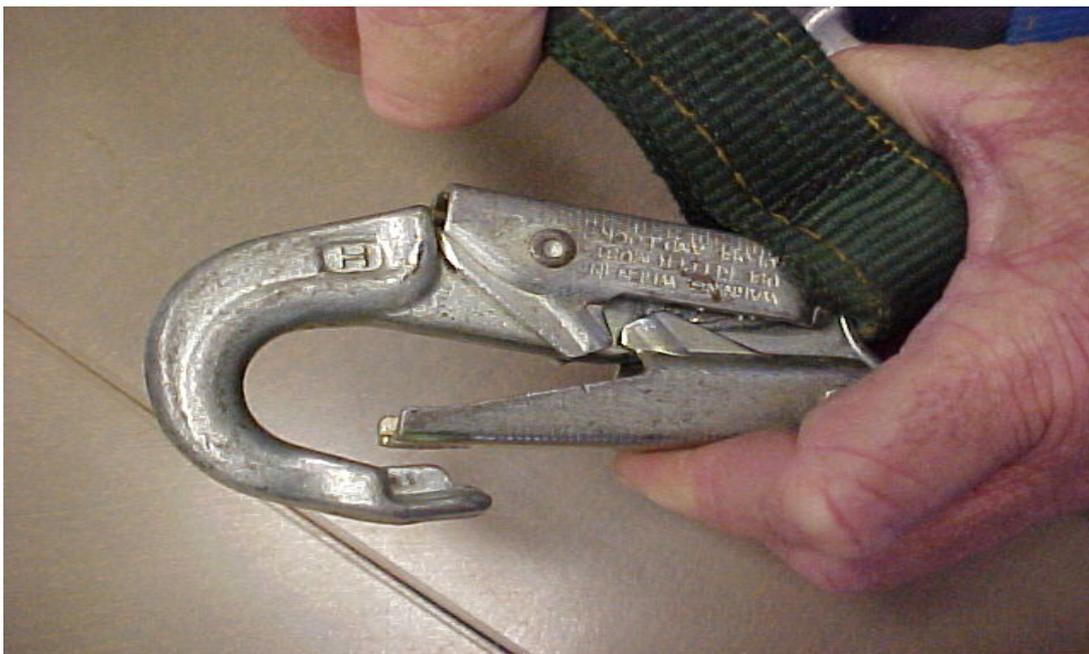
Photograph 6

Photograph illustrating operation of locking catch by rotating pole strap.

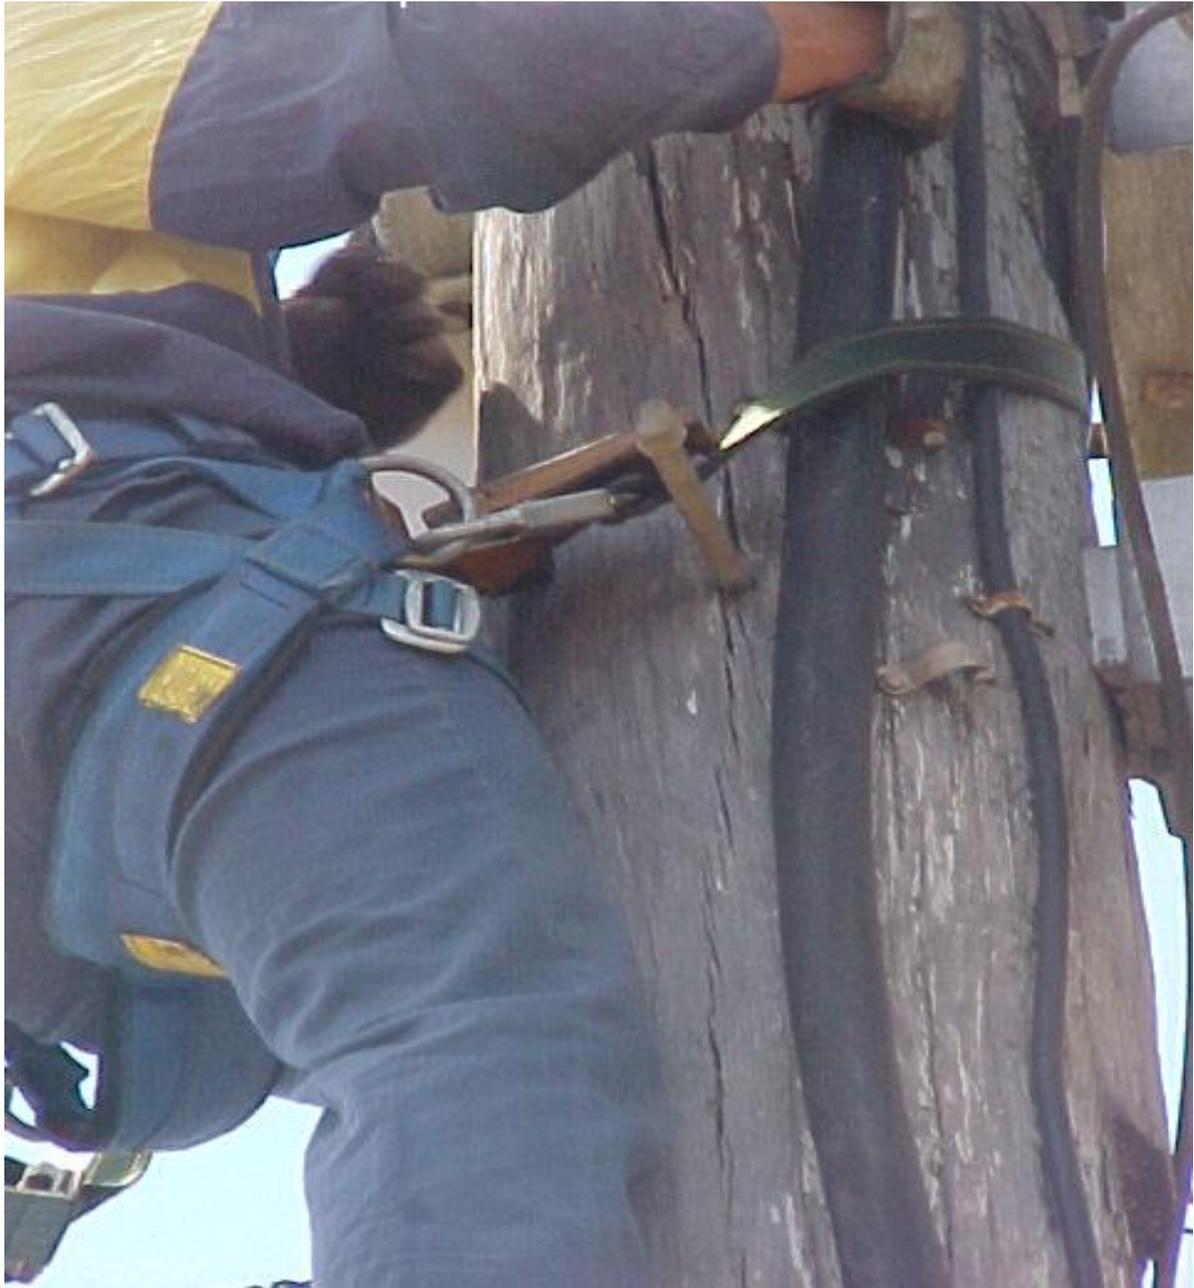
Photograph 7

This photograph shows the level of interference that can occur to the catches from both tool pouches and pole hardware. Staff should be alert to possible interference of the strap catches from these sources and the possible release of the strap under these circumstances.
