HSE Alert Form

Alert Number: **2014.40**

| eSafe No | 1116760 | Location | Corner Odessa & Ross Streets Granville | Date | 4 July 2014 |

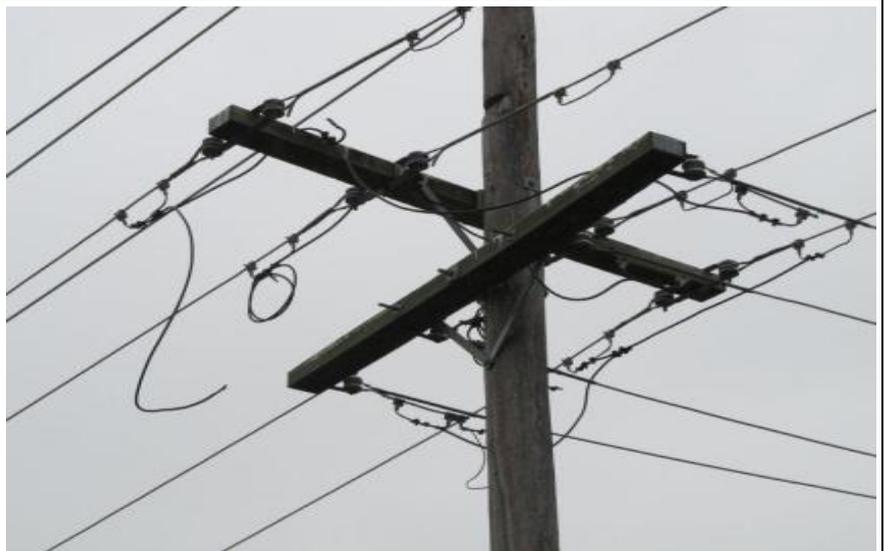
A Workgroup Leader had a report of a wire hanging from a pole. The WGL attended site and found one LV bridging conductor hanging from the top set of mains. It appeared that the bridges have been rolled up and tied back using plastic zip-lock cable ties to create an open point previously. One cable tie has failed letting the bridge hang low enough to potentially reach the bottom set of conductors on the T-off and had been left like this for a period of time. Unsecured conductors were made safe by removing bridges at the open point.

- Cable ties (zip ties) are never to be left on the Network as a long term means of securing conductors or bridges. Appropriate short term and safe use of Ergon Energy approved 9mm cable ties during construction is acceptable, but they must be removed and never left in situ once crews have completed their works at the site.

- Always secure effectively and prevent uncontrolled movement of conductors and equipment at all times.
- Ensure any tied back conductors / tails are held securely. Manage the risk of uncontrolled movement of conductor tails by;

- Cutting the bridge, leaving a short tail on the source side whenever possible
 - Securing the long tail by
 1. Bending back the conductor tail onto the main conductor and form the conductor into a loop, observing conductor minimum bending radius to prevent bird caging

2. Wrap the excess conductor tail by winding it around the main conductor
 3. Secure the tails with approved line clamps such as Parallel Groove Clamps. One clamp minimum per tail. Ensure correct size clamps are used, applied securely and correctly tightened onto the conductor. Ensure the conductors are correctly aligned and fitted into the clamp.
