DATE OF ISSUE (to ESAA): 28 Oct 2004	NUMBER OF PAGES: 3
SAFETY ALERT: 01/2003	ESAA NUMBER:

ESAA No: 40/2003

Safety Alert – Air Hose Incident

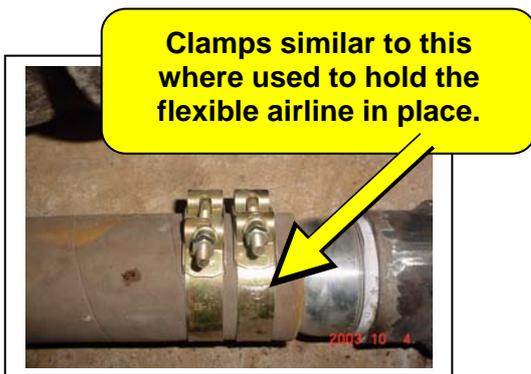
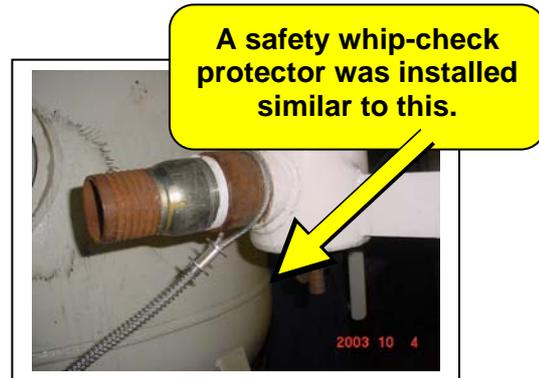
During abrasive blasting work at Barron Gorge Hydro Power Station, the point of connection between a flexible 75mm airline and air dryer (pressure vessel) failed. The two clamps and whip check came free. This failure resulted in the airline becoming free and uncontrolled. The abrasive blasting work and plant were under the control of a contractor.

1. Identifying any plant / equipment or work where 690 KPa (or greater) flexible compressed airlines of 25mm diameter (or greater) are being used (smaller airlines and hydraulic systems will also be reviewed).
2. Identifying the owner of the plant / equipment (including if it is hired).
3. Identifying the means of connection (include type / brand of hose, whip check / safety chain, hose clamping system if fitted and if clamping system fitted, who fitted the clamp, what the hose is connected to) between hose lines and / or plant and any existing safety procedures / inspections being undertaken.
4. Ensuring that the equipment is in a safe condition and if necessary tagged "out of service" and then undertaking repairs or remedial action to protect the area until repairs or replacements can be completed.

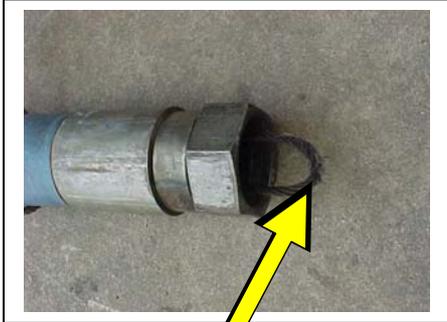
Examples of equipment not fit for purpose.

Some hoses have internal whip-check protection – wire rope up the inside of the pipe.

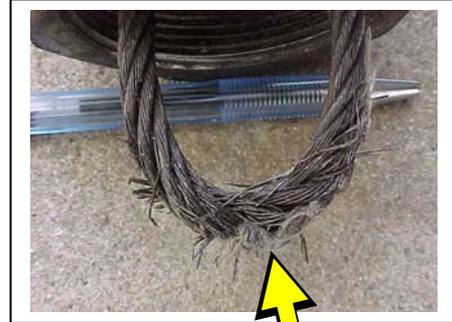
An internal whip-check protection in a poor state of repair – frayed wire.

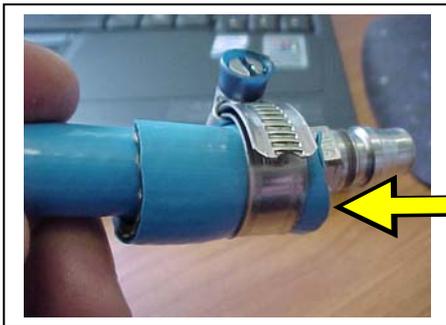
An example of an airline being used by a contractor. A piece of extra hose was fitted under the worm drive clip to allow the hose to be tightened onto the barbed air fitting.

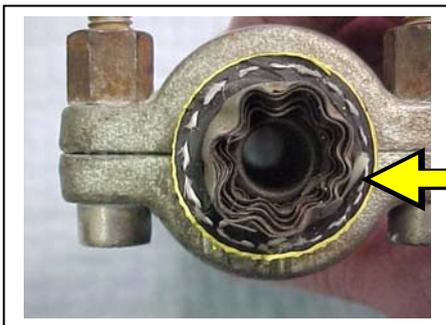
From the photo you can see the use of duct tape to increase the size of the barbed tailpiece.
