HSE ALERT

RMSS #15101

Tracking # 90

Date: 09/10/14

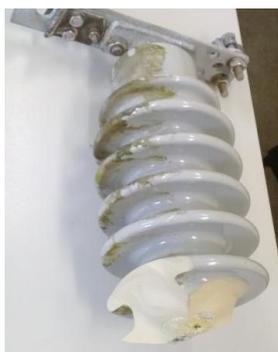
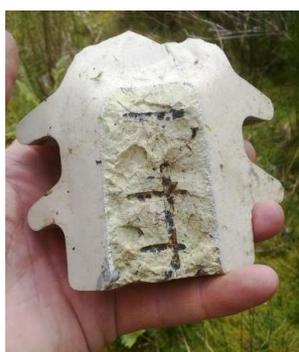
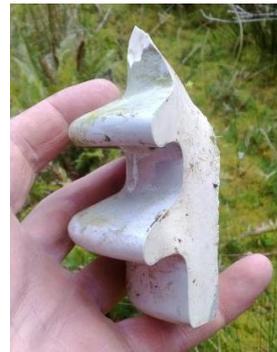
On 7th October, an operator opened an Air Break Switch (ABS) to isolate part of the network at Queenstown. A piece of the ABS broke away during isolation and hit the operator on the left shoulder. The ABS did not pierce the skin, but has left bruising. The same ABS was operated the previous day, without any noticeable defects or faults occurring.

This incident is another in a trend of increasing ABS failures. The reason the incidents are occurring is because the ceramic insulators have been weakened beyond their design stresses, and subsequently fail during normal operation of the switch.

1. Field crew are to continue using the control measures provided in Red Alert (#87) when operating ABS:
 - Prior to conducting switching, inspect both horizontal and vertical air brake switches using binoculars as close as possible without encroaching on safe approach distances. Use an EWP, or as a last resort, a ladder to inspect the insulator, looking for hairline cracks.
 - Before conducting any air brake switching, ask distribution operations to set the relevant feeder to 'one trip to lock out'.
 - If responding to a fault, conduct a risk assessment to seek alternate isolation points to mitigate the need to operate an ABS.
2. Maintain drop zones: ensure the worksites are clearly marked, additional crew members stand clear of the drop zone during switching and, if applicable, barriers need to be used to prevent pedestrians from entering the drop zone.

On Friday, Field Operations Leaders will review effectiveness of proposed medium term solutions, including engineering controls. The group will also review the current control measures that are in place. An ABS operating procedure will be developed and distributed next week.
