# *Safety Advice 01-2004 (NZ)*

## **UNAUTHORISED ACCESS OF POLE STRUCTURE**

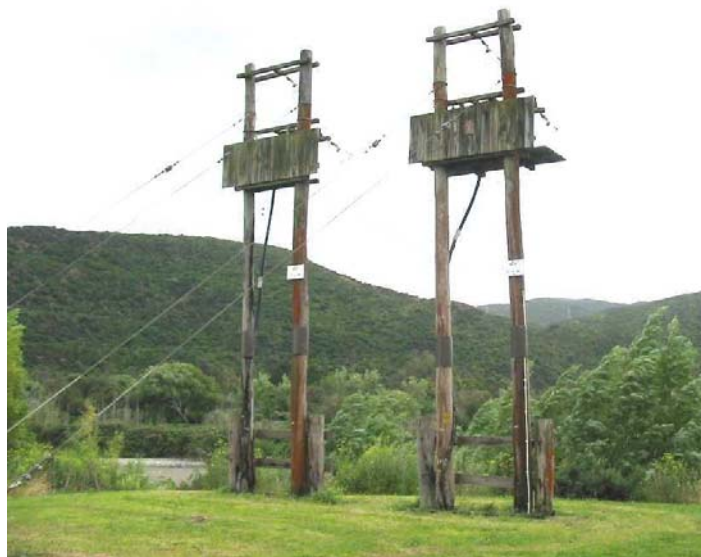
The child gained access to a wood pole "pi" structure which was a cable termination to an overhead line forming a river crossing. Contact was made with a live cable tail causing the child to fall some 5 m to the ground. The child received burns as a result of contact with live parts and other injuries as a result of the fall.

Climbing steps were fitted to the poles and these complied with ECP34 cl 7.3.2 (being not less than 3 m above ground level). Stub poles were attached to the main poles as part of the design and from here, assisted by a friend, the child was able to gain a handhold onto the lower climbing steps and ascend the pole.

The lower climbing steps have been removed, anti-climb devices (eg. barbed wire / possum guards) attached to the pole just below the climbing steps and emergency contact signage attached to the structure. Networks with similar structures may wish to review these assets or locations within their area as a further step to prevent unauthorised access.
