# Incident Alert

INSULATOR FAILURE 33kV Disconnecter

Sunday, 22<sup>nd</sup> November 2015

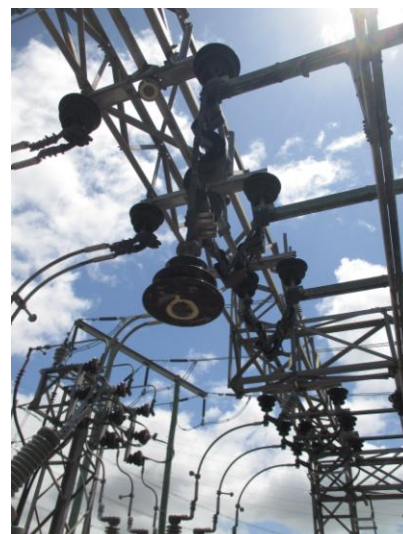
The moving section of the Canterbury Engineering under hung Disconnecter (Blue phase), has broken away from the top cap, this has caused the entire pantograph section to swing into the live 33 kV BUS.

The failed section being blue phase swung and hit the blue phase of the live bus, so there was no phase to phase short.

Photo showing the Pantograph section hanging prior to removal

At day break a team of projects and maintenance staff were mobilised and tasked to remove the damaged disconnecter and insulators.

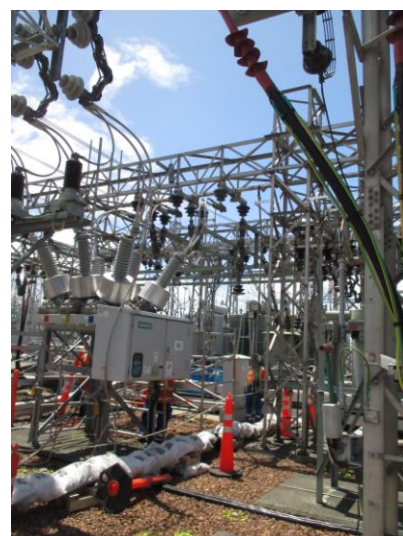
Photo of circuit, note that the position of the staff member is where the operator would be

The 2 switching operators immediately cleared the yard and advised the Transpower National Grid Operating Centre to clear the bus for isolation.
