# Lessons Learnt

**Incident Title:** Flashover of J Type Fuse

**Date of Incident:** Monday 26 September 2016

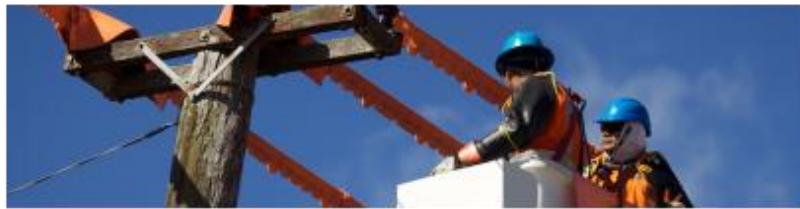
A fault technician was attending a call of no power. Two ruptured J type fuses were found at the local transformer. In the process of replacing one of the fuses, a flashover resulted. The cause was a cable fault and “rocking” the fuse into the fixed contacts. The fault technician was wearing appropriate PPE; full face shield, insulating gloves and FR work wear. No injury resulted.

- Remove the ruptured fuses and check no back feed is appearing on the load side of the fuse.
- Replace fuses in carriers and ensure fuse holding screws are tight and the black fuse carrier toggles are fully undone. Lubricate contacts of the fuse and J type assembly with petroleum jelly wearing insulating gloves.

- Hold fuse carrier slightly out from the fixed contacts and “punch” in. **Do not rock the fuse** as the barrel of large fuses is likely to contact the fixed contact resulting in a potential flash over in the event of a faulted cable.

- In the event a cable fault exists, do not attempt to remove the fuse. Allow the fuse to do its job. (This may even take out the 11kV high side fuse.)

- Check no back feed is appearing on the load side of the remaining removed fuses.
- Repeat replacement as per bullet three.
- This pillar style is gradually being replaced as part of asset replacement with NH fuse frames.
