# *Safety Advice 19-2008 (NZ)*

## **Trainee Line Mechanic - 7 meter fall from tree**

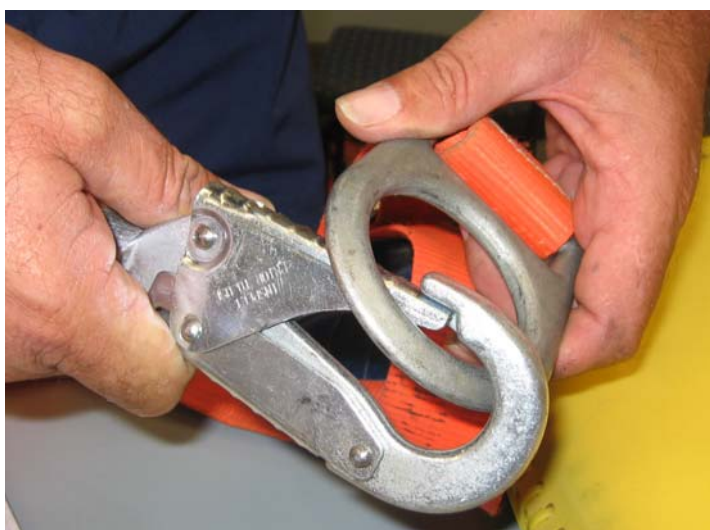
The pole strap is twisted so that the "D" attachment can push against the operating latch.

- Before each use hooks should be checked for correct operation
- If hook does not close and lock the mechanism may be partially jammed, bent or the spring weakened. Unless cleaning rectifies the problem the hook should not be used
- Loose clothing should be avoided as it may become entangled in the hook and prevent closure
- Visual check should be made to ensure that the hooks are closed fully and they are not tangled in clothing before entrusting your weight to the belts
- Check, by twisting the connecting device to and fro, that an accidental uncoupling or "roll-out" cannot occur owing to the snap hook latch being depressed by side of the D-ring

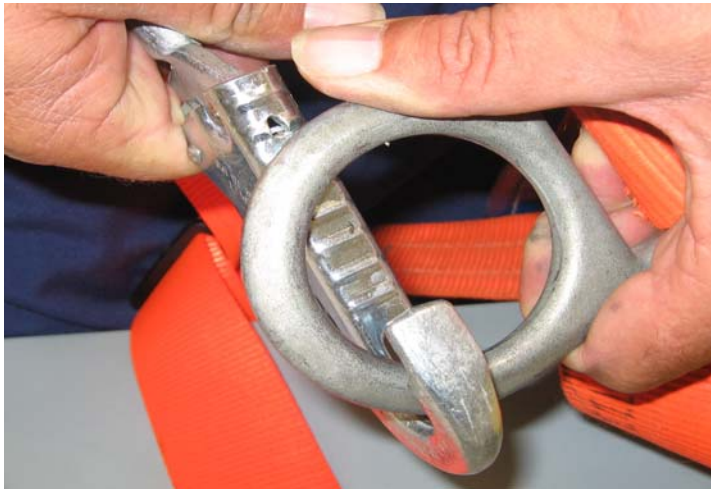
A small amount of pressure is applied allowing the safety latch to open (a twisted strap can exert enough pressure against the operating latch).

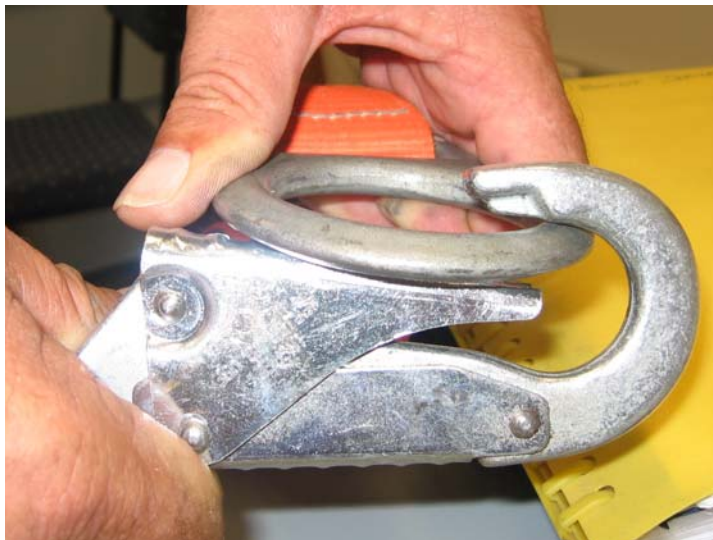
The "D" section of the safety belt can now slide out of the safety latch leaving the user of the belt unattached to the structure or tree.
