# ENVIRONMENTAL ALERT

Day Month Year 30/1/2017  
Maximo Reference: 96413

## Oil Spill on Public Road

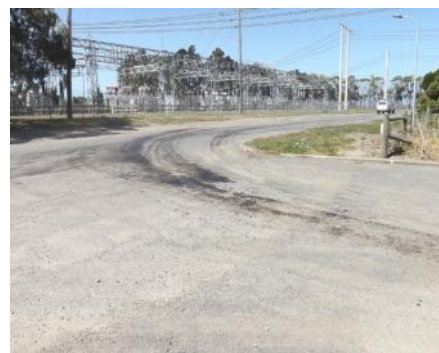
An oil spill of approx. 20 litres onto a public road occurred when a scrap dealer removed the former Bromley T5 220/66kV transformer "A frame" radiators.

The scrap dealer had requested the isolation valve on the "A frame" radiator be removed to avoid needing an over width transport permit. Instead the valve manifold was covered with plastic and taped off.

An excess of residual oil was also left inside the radiator and this was sufficient to surge and break through the plastic and tape seal, as the truck moved off.

- ) Oil spill was covered with sand and hydrated lime.
- ) Regional Council and City Council advised and inspected the clean up.
- ) Additional effort to remove as much of the residual oil as practicable.
- ) More robust arrangement of blanking the radiator manifold adopted.

TP.SS 04:55 "Removal, transport, storage and installation of power transformers" should be followed as best practice, even when the transformer is being scrapped.

If isolation valves are to be removed for transport, then robust plywood or metal blanking plates should be employed.
