Memo

Ref: Cable Drum Rack Memo 1.0

SUBJECT: Cable Drum Racking Systems

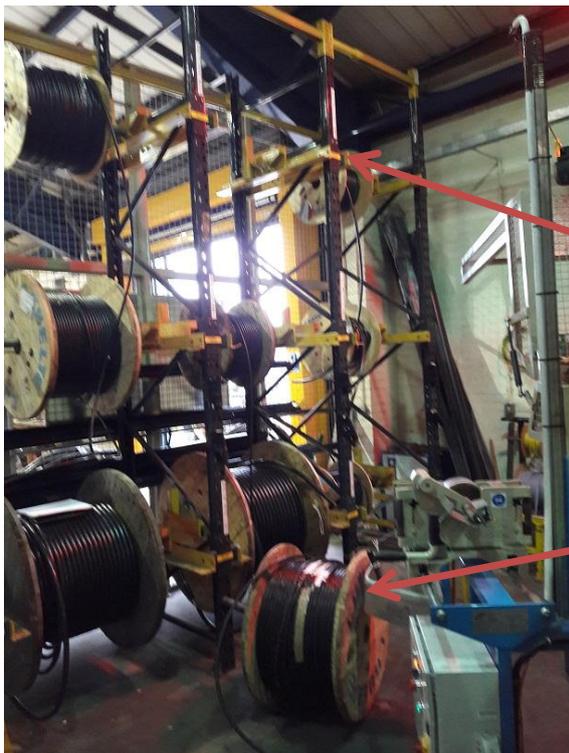
Cable drum and bar fell from here and landed here.

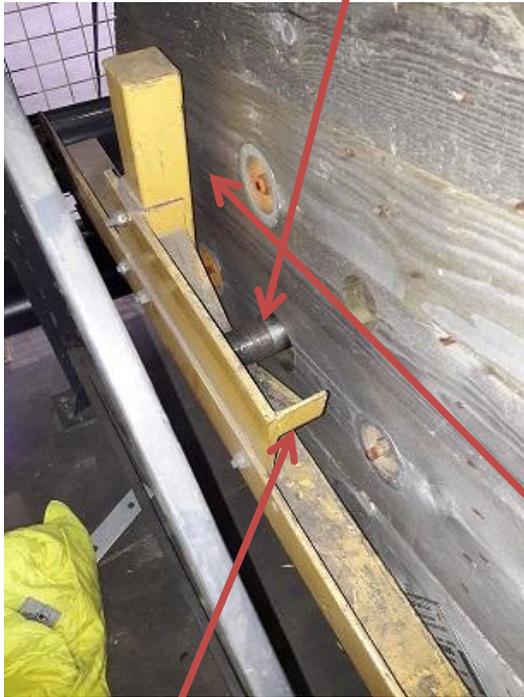
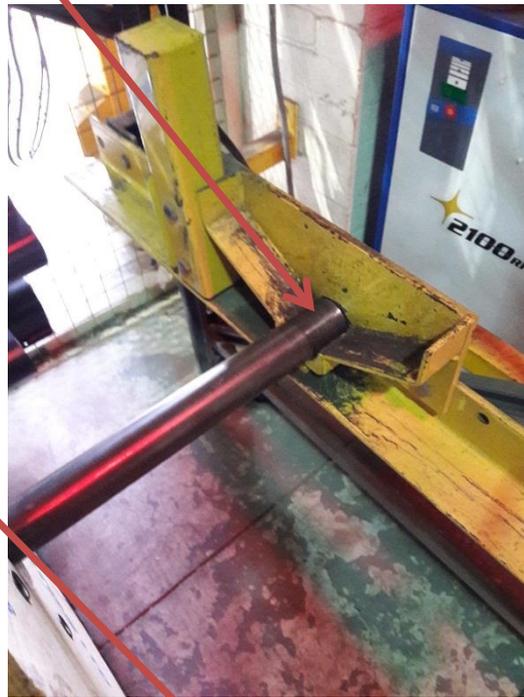
The drums are lifted by fork lift truck and the drum bar should slot into the V shape at each side of the carrier. On the left cable drum and bar and the right hand side picture just the drum.

When the Fork Lift Truck lifted the drum, rather than hitting the back stop, it hit the front of the V section and then came to rest unsecured on the L shaped cross brace with the driver assuming it was properly engaged in the V.

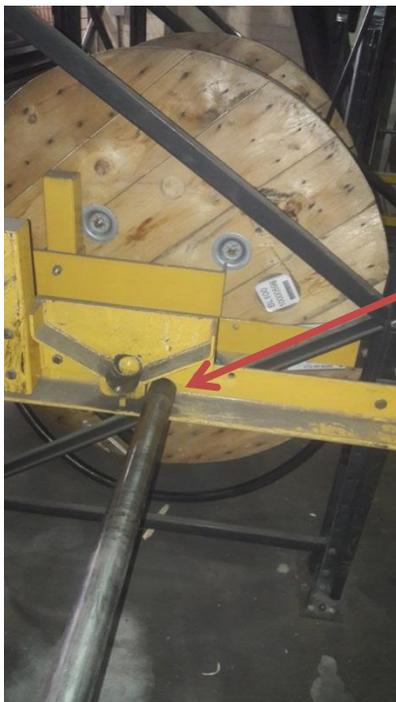
This pictures show the drum bar (without the drum for our investigation reconstruction) incorrectly located on the L shaped cross brace. This allows for it to easily roll along the channel and fall to the ground.

If the bar is misplaced on the racking it can be seen from ground level but it takes deliberate 'conscious' observation, not just a glance. We concluded, amongst other things, that a factor in the accident was a single human error that went unnoticed. As we have 'humans' doing this every day we want to design out the risk. Hence, the reason for changing the racking to something that is more
