# SAFETY ALERT

## Subject: Altec LR756 EWP Slips off Leg Block

Date: 28 May 2019

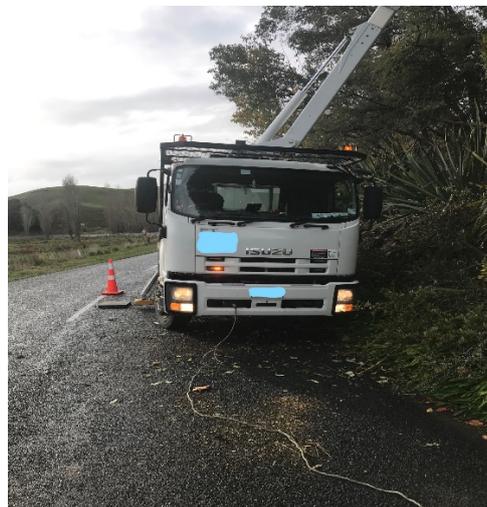
**Description:** An Altec LR756 single man EWP used for vegetation management was being used at full extension to remove vegetation around an isolated service line from the roadside. The EWP had been set up with both outriggers sitting on proprietary leg blocks on the asphalt. During the process, the EWP has slipped off the inside leg block resulting in the EWP shifting sideways. The EWP was on a slight slope but not outside the manufacturer's guidelines. The arborist self-rescued using a rope and descender. The EWP has different leg feet to other EWP's in use and the difference in stabiliser feet is currently being investigated

Normal foot

Affected foot

- Ensure one of the EWP's rear wheels is tightly chocked front and rear of the same tire to prevent vehicle rocking
- Where slope exists, deploy the low side outrigger to a firm footing. If off the road, you may have to dig to level and firm ground to accommodate the proprietary leg block. Then extend the high side outrigger to ground level and then extend a further 100 mm. Extend the low side outrigger to establish a more level vehicle. It may not be possible to get the vehicle to 0 degrees on the slope indicator even with the low side outrigger at full extension. Ensure the EWP ends up within the limits shown on the slope indicator or utilise another leg block. Do not retract the high side outrigger to level off.

- To ensure proper outrigger spread when using pads or blocks on level or sloping ground, extend the outriggers approximately 100mm after reaching ground level (not pad surface level.)

- All tires should remain in contact with the ground surface
