# FIRST ALERT

Maximo Reference: 96994

## 220kV Disconnecter Left Unlocked

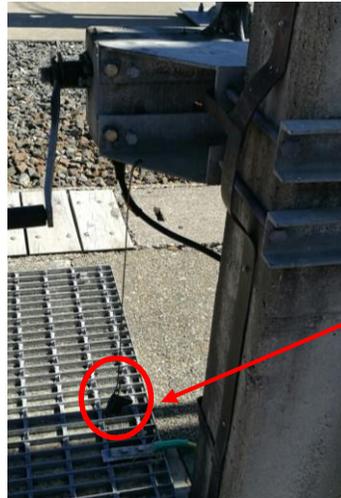
- Disconnecter 704 at Invercargill substation was found unlocked by a Grid Skills trainer on 8/3/17.
- On 10/2/17 this disconnecter had been closed as part of a planned switching sequence.
- The operator has removed the padlock from the disconnecter, performed the switching action and then failed to re-attach and lock the padlock.
- The key for the padlock was found back in the key safe.

Padlock hanging on stainless steel wire below the disconnecter

- When the disconnecter was found to be unlocked it was immediately locked and the disconnecter contacts visually checked to ensure they were fully closed.
- Transpower and Electrix management advised.
- Investigation commenced.
