# People - Safety Incident Alert

## “Lost Time Injury” (LTI) Event

Date: 20 November 2019

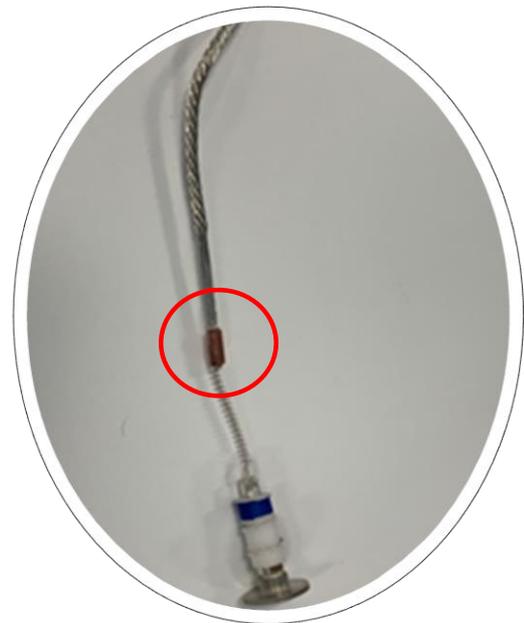
Whilst responding to a fault on the Orion 11kV overhead network after an electrical storm had moved through the Canterbury Region, an Orion Network Operator sustained an injury to his face when struck by a small metal fragment ejected from a drop out fuse when it was closed onto a faulty transformer.

Orion requires that Network Operators complete this type of operating activity from the ground, and in this case the Network Operator was positioned 4.8 m from the base of pole and the distance to the drop out fitting was 7.9 m while using an insulated tele-sopic fuse stick.

- A Safety Advice is to be developed and issued to the wider industry for awareness and learning
- Orion are reviewing the current PPE Standard to ensure the PPE criteria are applicable to the current Network Operator work activities
- Ensure that a Risk Assessment is performed before work is commenced (Refer SM-EI / 3.303)
- Always review and confirm that your hazard treatments, are fully effective for the duration of the task (Refer SM-EI / 3.303)
- Ensure that PPE requirements are appropriate for the activity being undertaken (SM-EI Part 2 Section 13 - PPE) as a minimum
