Safety Advice 30-2013 (Sept) (NZ)

FIRST ALERT

Internally Fused Capacitor Bank Maintenance

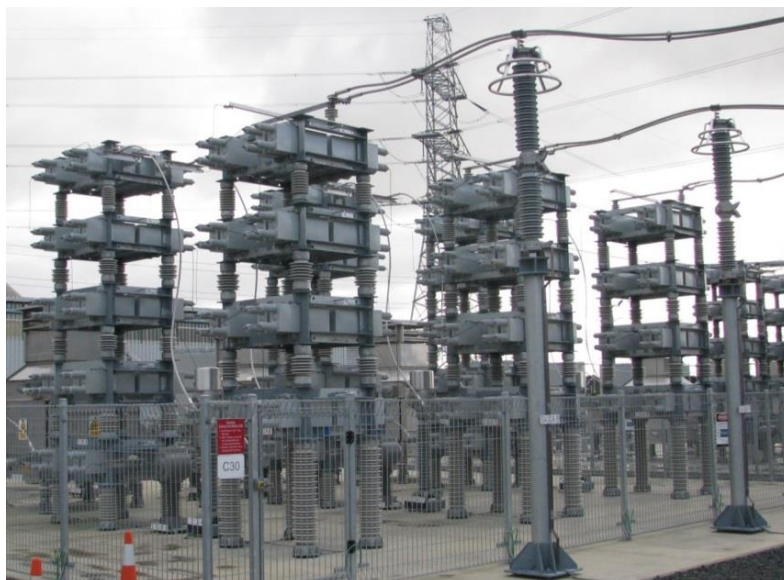
It has come to Transpower's attention that a practice of purposefully blowing fuses in capacitor bank cans is being carried out to clear capacitor bank unbalance protection alarms.

This process involves charging a capacitor can with an insulation resistance meter (ie Megger), then shorting it out with a screwdriver or similar to blow the can fuses and thus return the bank to balance.

It is also extremely important that capacitor banks are not operated with a number of blown capacitor cans (but balanced) as this puts the capacitor bank at a heightened risk of explosive failure.

This procedure is **dangerous, totally unacceptable and is to stop immediately**. The correct response to a capacitor bank unbalance alarm is to identify and replace any defective cans with the appropriate spares.
