## Safety Alert – SA378

### Fractured Finger – Vegetation works

Q-Pulse Number: NPRR16324

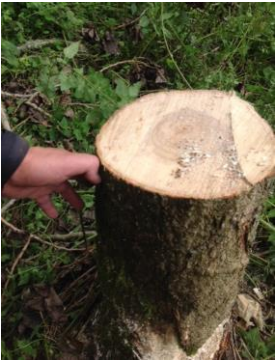
| Incident | Description |
|---|---|
| <b>Re-enactment photo</b><br> | <b>Event Description:</b><br><p>A four man Vegetation crew were working on the OHK-EDG-A 68-69, removing sag poplar trees. After felling one of the trees there was a metre high stump left behind which required cutting. When the employee had completed the cut he pushed it over with his hand; the stump came into contact with surrounding scrub and pushed the stump back into employee's thumb.</p> |
| <i>Potential Outcome:</i> | <p>The employee sustained a fractured thumb.</p> <p>The investigation identified the following:</p> <ul style="list-style-type: none"> <li>• Best Practice Guidelines were not followed</li> <li>• Lack of planning</li> <li>• Failure to identify the overgrown scrub as a hazard in the pre-start</li> </ul> |

| Incident | Description |
|---|---|
| <i>Actions Required / Messages:</i> | <p>The Vegetation Work Instruction TM-VG-WI002 is to be updated to include the planning process around clearing scrub around the base of the trees prior to felling.</p> <p><b>Note: This update must be communicated to all vegetation crews across the Northpower business.</b></p> |
| <b>Worksafe</b><br>Best Practice Guidelines for Safe Manual Tree Felling 2.2.3 | <b>Preparation of the work areas and escape route</b><br>Clear vegetation and obstacles from around the base of the tree. |
