## Newsflash - 2017 11

## Inspecting Work at Height Equipment

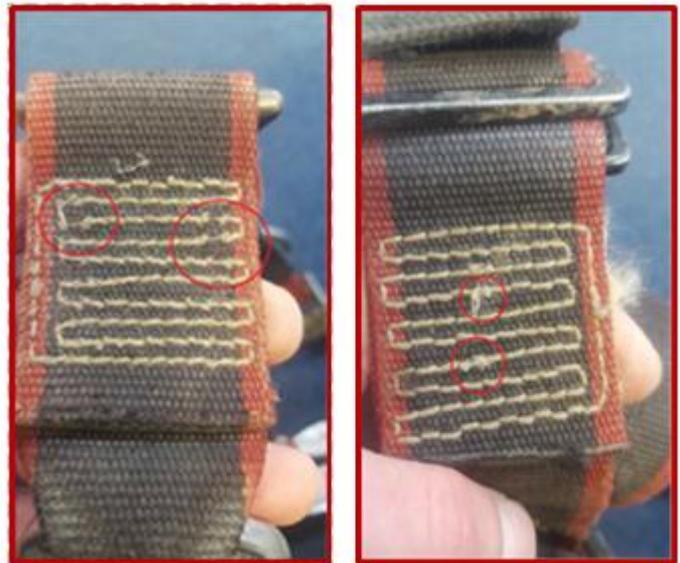
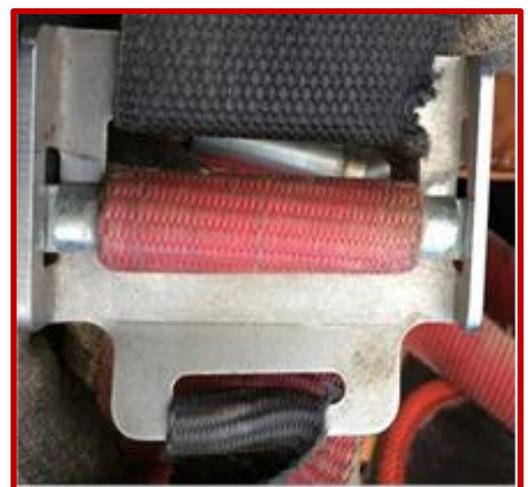
During formal inspections defects were found relating to wearing of the stitch patterns on the front attachment of two Cresto harnesses. We returned the harnesses to the manufacture to gain their views on the defects. **The defects were considered safety critical and the harnesses were failed as a result.**

In addition, another DNO had a serious near miss where the webbing on a choker tore significantly. Adjustable buckles were found to be causing rubbing/cutting damage to the webbing. Since then we have found a number of pole chokers with 1-2mm cuts around adjustable buckles in Northern Powergrid.

When carrying out a 'pre use inspection' look for any defect which could lead to a failure of the equipment.

- Look for defects such as cuts, tears, worn stitching etc. which may affect the integrity of any webbing or ropes.
- Check that all metal work operates smoothly and that any self-locking gates return to a secure closed position easily.

**Under no circumstances should equipment which is damaged or defective be used and must be replaced. Do not put your life at risk.**
