TRANSPOWER

SAFETY START

12 June 2018

Live wire ends floating in amongst equipment

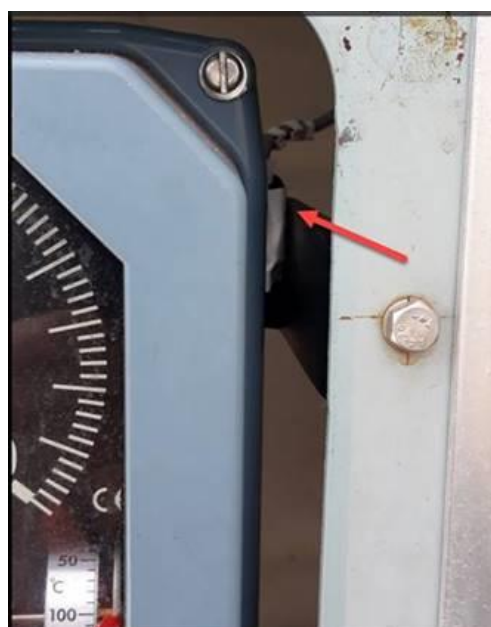
Whilst undertaking work on the Redclyffe (RDF) Protection Upgrade, a Broadspectrum technician noted two wire ends had been left floating in amongst the equipment and wiring in the RDF T4 Cooling Control Cubicle. These wires were later proven to be live at 110V DC.

The red arrows on the photos below indicate the live wire ends.

Upon discovering these wires, the technician worked methodically to determine their origin and purpose before isolating the source of supply and eliminating this hazard.
