Hawera Substation 60 ton press hose burst

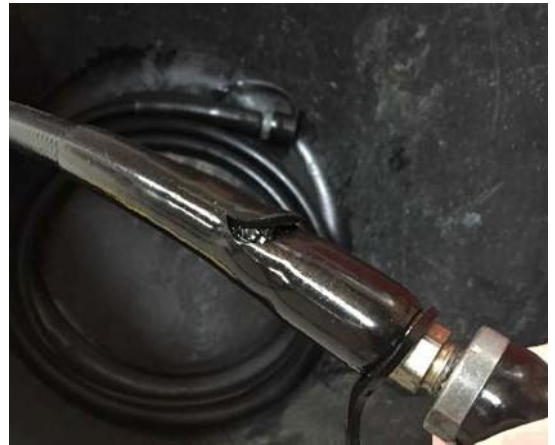
While pressing a Cicada dead-end termination for the new HWA Bay 100/110 bus as part of the HWA 110kV Bus Rationalization Project, the 60-ton press blew its hydraulic hose causing a minor oil spill on the switchyard metal.

Suspected hose fatigue. The press is serviced every two years, which includes a visual inspection of the hose. The failure occurred under the crimp section of the hose where it is covered by a sleeve.

The age of the hose was unknown at the time of the incident, but post incident investigation identified the hose to be more than 10 years old.

After consultation with hose supplier, hydraulic hoses have a maximum of 10-year life expectancy dependent on condition and volume of use.

- Minor spill on switchyard metal clean-up and supervisor notified of incident.
- Hose removed from site and taken to Energy Hydraulics in New Plymouth for replacement.

- Recommended life expectancy of hydraulic hoses is around 10 years depending on its use.
- ABB to place expiry date onto hose. This date will indicate the date in which the hose must be destroyed, unless determined prior through visual inspection deems hose unfit for service.
