Cut hand stripping cable

WHAT HAPPENED?

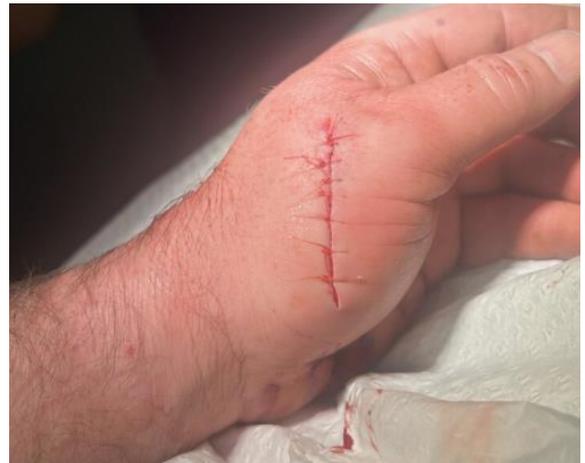
Whilst a Trainee was stripping a cable, the cable stripping knife slipped, resulting in a cut to the base of the thumb requiring medical treatment and seven stitches.

Figure 1 - The IP's cut to thumb

- Position of the hand whilst cutting cable.
- The worker had taken their gloves off to check the time on their phone and forgot to put gloves back on.

- Always cut away from yourself.
- Always wear the correct PPE for the task being undertaken.
- Use the correct method and procedure for the task being conducted.
- Stay focused on the task to ensure all safety measures are in place e.g. where stopping to check the time on your phone and removing your gloves, you need to remember to put your gloves back on.
