Misuse of a Handline Block (LL259)

Incident		Description
Event Date: 02/07/2024	Time: 11:30 a.m.	Location: BPE-HAY-A0225
NP Reference / External Reference: OCC13994 / INV15960: Maximo Incident 174887

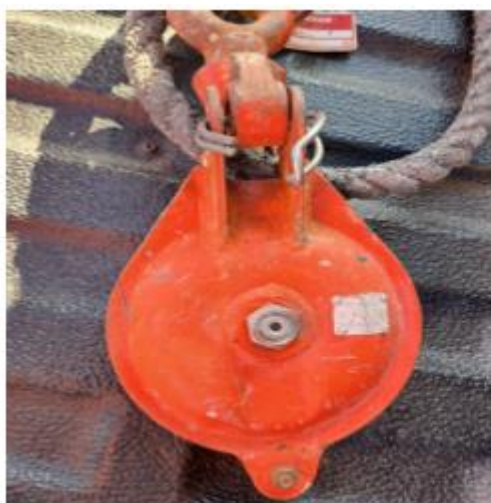
During a tower refurbishment job on the Bunnythorpe – Haywards A line, the team realised one of the two available handline blocks required onsite was missing a pin to hold it together. Instead of removing the handline block from service, it was decided to use the block with a ground matt pin to hold the block together to complete the job.

Figure 1 Photo of the Block with Gound Matt Pin

Using a handline block without the correct pin could have resulted in objects falling from height due to the improvised pin causing the block to fail under load.

Complacency - The crew failed to address the missing pin for the handline block effectively when selecting the equipment at the yard and again before proceeding with the planned work onsite.

Reiterate the processes for tagging and testing equipment with a focus on the immediate removal from service. Ensure that the removal from service is also reported to Team Leader/Supervisor immediately. Reiterate to all field staff the critical role these steps play in maintaining safety and operational efficiency.

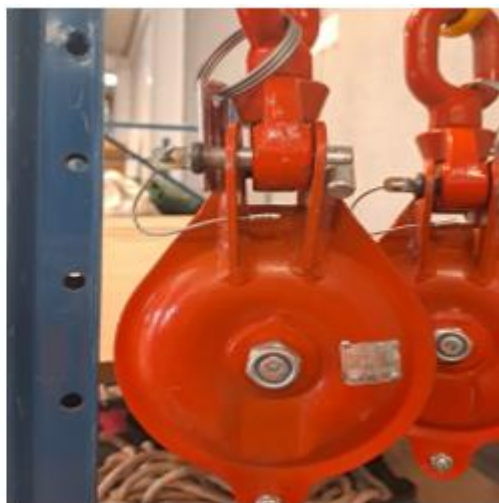
Figure 2 An example of a Block with the correct pin
