Extension lead run under door frames

What happened?

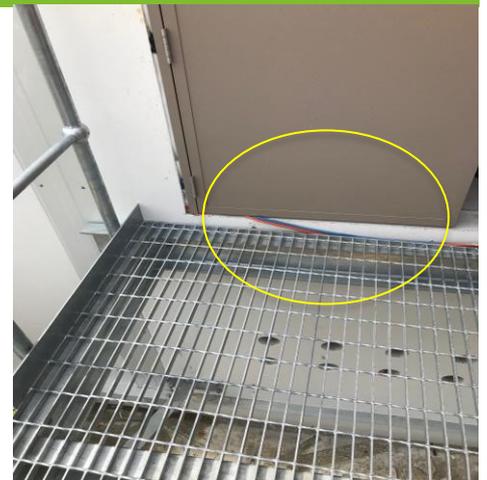
Whilst undertaking a site visit, it was noticed that extension leads were run between the gap of a newly constructed switchrooms building personal door and the floor plate.

The action of running leads between gaps under the floor or through a door opening has resulted in personal harm previously.

This safety alert is to remind all staff the hazards of running extension or any other lead carrying that may carry voltage or current through doors or openings where they could be closed on the leads resulting in mechanical damage

Work was stopped and all extension leads were re-routed through other accessways (IE core drilled holes and floor openings) to avoid running through accessways that could cause mechanical damage.

Where there is the requirement to run extension or test leads between rooms including in/out of a building, a suitable route must be established including a risk assessment undertaken, to ensure the leads can be run in such a way as not to sustain mechanical damage.
