Near Miss – Dropped Pole Chain Strap

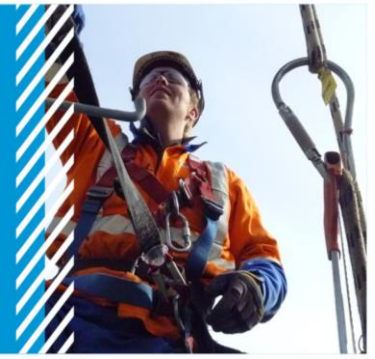
Following on from a First Alert where a tower painter was able to undo both ends of his chain pole strap, which caused it to drop approx. 40m hitting several minor members on the way down.

Staff member was able to inadvertently entirely detach himself from the pole strap.

- A solution has been found whereby FTPS (Fitzroy Tower Painting Services) are now using 1100kg rated maillon carabiner. This needs to be nipped closed with a spanner preventing it from coming undone and therefore providing a secure anchor point to the erator's full body harness & accidentally falling from the operator's person. Include references to regulations or approved codes of practices. (Attached above is a picture of the new pole strap maillon carabiner)
- FTPS is currently in process of replacing the clips with rated maillon carabiners onto all chain pole straps. These will be certified and added to the testing program register.
