# Incident Alert

OTA CB Manually closed without operational control

20 November, 2015

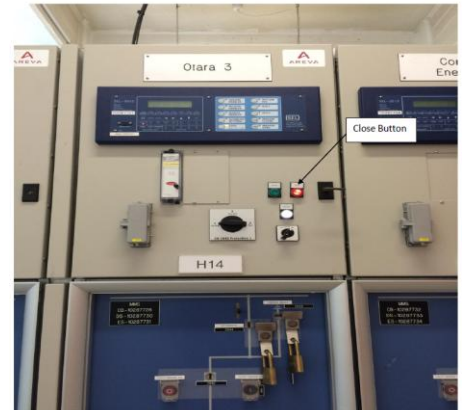
During the identification of a cable marker, OTA CB 2842 was opened remotely by the NGOC (National Grid Operating Centre). The timing of this operation meant that the Technician believed he had caused a tripping and had inadvertently caused the opening of the circuit breaker. He checked that there was no fault flag on the relay and pushed the manual close button on the relay panel to reinstate the circuit breaker.

Photograph showing the Close Button

Only a maintenance switcher who has operational control of the equipment or under the direction of NGOC can operate in-service or out of service equipment.

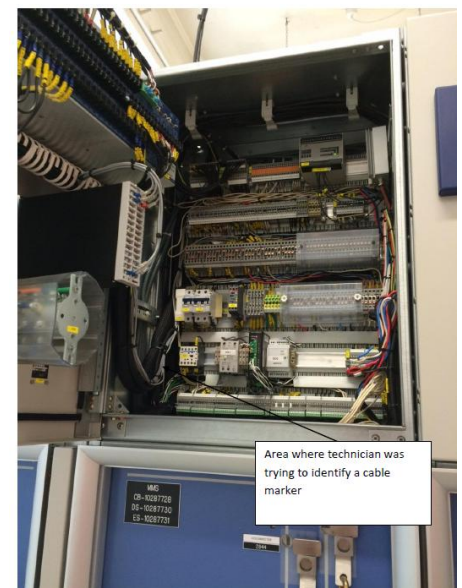
As part of the OTA CB 2842 PROT FAIL SCADA point survey for the SMS upgrade project a Technician was undertaking work to identify a cable tag inside the OTA CB 2842 relay panel above the switchgear.

The area the Technician was working in when the incident occurred.
