# Incident Alert

Inadvertent close of a 22 kV circuit breaker

Friday, 20th November 2015

Alert Number: 13012016

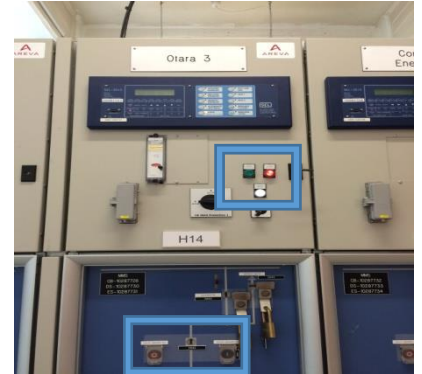
A Technician carrying out cable identification work in a 22 kV metal clad switchgear control/protection panel was startled, when the circuit breaker was opened remotely as part of planned switching by the National Grid Operating Centre.

As he checked the status of the open/close LED's on the panel, he inadvertently applied pressure to close the LED/push combination button and closed the circuit breaker.

Upper control/protection panel with exposed LED/push buttons and lower CB panel with push buttons fitted with protective flip covers

1. When commissioning or decommissioning alarms the RTU configuration file and drawings must be updated.
2. Hazards must be reassessed when work changes from the original job scope.
3. When working in switchrooms consideration needs to be given to the operation of switchgear as part of the hazard identification process and if required advise those with Operational Control of the equipment of the presence of workers in the switchroom. Particularly when working on or near the switchgear.
4. Fitting flip covers to combination push button/LED devices should be considered.
5. Cable numbers should be installed so they are able to be read without having to handle the cable as much as practical.

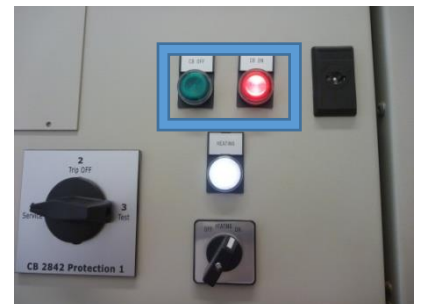
Combination open and close LED/push buttons
