Incident Alert Form

Significant Near Miss While Driving

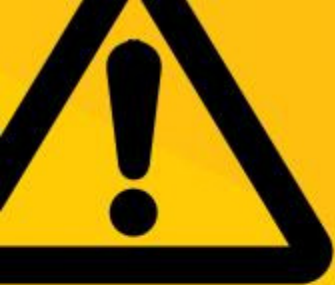
While over taking a Concrete Truck in a passing lane, the accelerator pedal was obstructed by the floor mat and the accelerator got stuck on full throttle. The vehicle accelerated up to approximately 160km/h before the driver was able to free the accelerator pedal and regain control of the vehicle speed. No accident happened but it was a significant near miss.

The mat and restraining clip

Clip fitted below driver's seat

The fixing system that had been used for the mat had broken at some point and the defect was not identified and corrected.

- Secure or remove driver's side floor mats on all vehicles.
- LeasePlan are investigating a permanent solution across all work vehicles. Once approved, this will be communicated to all sites.

Any unsecured mats on the driver's side of work vehicles need to be either secured or removed until a permanent solution can be implemented.
