Incident Alert

Low Exposed Terminals & Metal Cabinet Gland Plates

Thursday 26 June, 2014

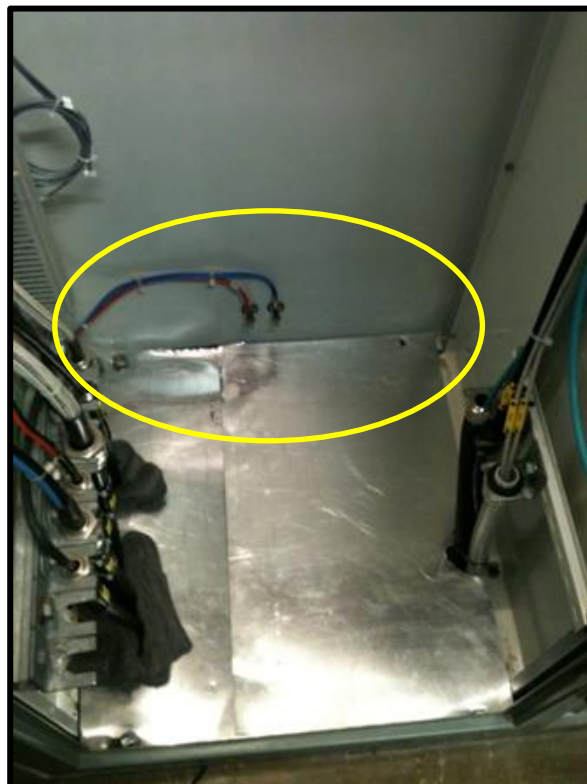
While pulling cables, a metal vermin proofing plate was accidentally flicked up, causing a short across two test terminals that were located near the bottom of the cabinet.

This in turn caused the associated fuses to blow.

Test terminals & proximity to metal plate

- Be aware of test terminals located near the bottom of cabinets in combination with metal vermin proofing/gland plates. Note the increased risk when working in such cabinets.
