# *Safety Advice 52-2013(Dec) (NZ)*

## *Transmission – Electric Shock*

Lost Time Injury: 220kV Electric Shock

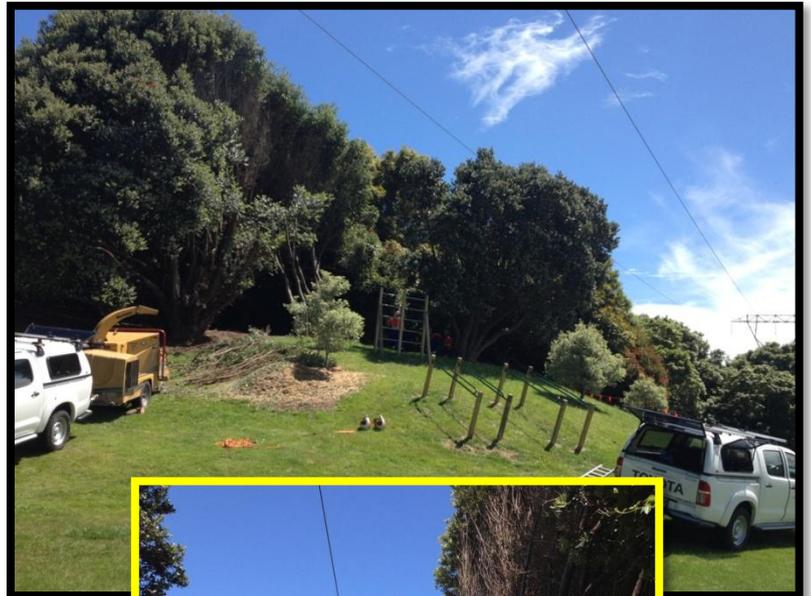
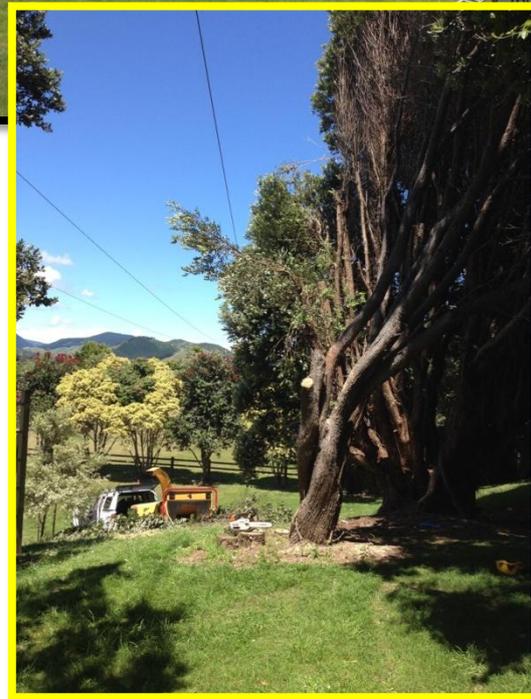
A Transfield Services Vegetation employee received an electric shock while he was working to clear a Pohutokawa tree from the BPE-HAY-A line.

The injured employee was taken to hospital by ambulance, has been treated for third degree burns to his right hand and left foot (the entry and exit points). He remains in hospital under observation.

**When working around live conductors always refer to SM-EI's.**

**Rule 3.703 states the reduced minimum approach distances for certain employees near exposed live conductors.**
