FIRST ALERT

Polystyrene Cladding Blown Into Switchyard

Location: Balclutha Substation

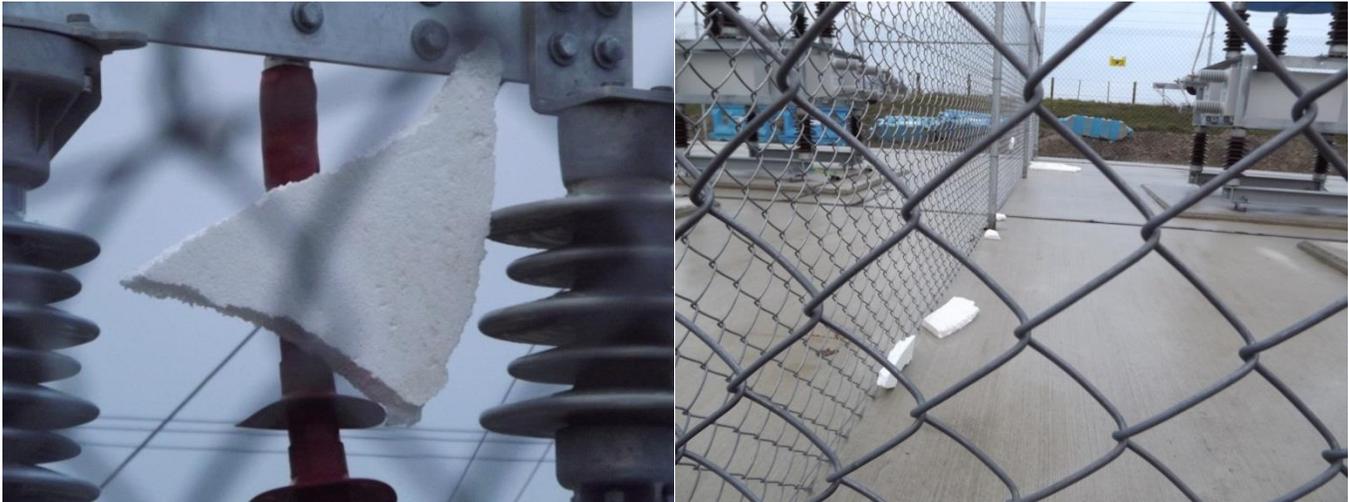
During extremely high winds polystyrene cladding from the new Balclutha Switchroom was damaged and blown off the building into C1 and C2 capacitor bank yards.

There was potential for a flashover of the 33kV capacitor bank equipment.

- Polystyrene was re-secured to the building wall to ensure no further sections were able to be blown off.
- Fragments of polystyrene removed from the yard.
- Ensure all loose materials are secured to prevent them being blown around in the event of high winds.
