Subject	Serious Harm Accident Investigation Update		
Alert Number	SA 085	Date Issued	29/08/2014
Issued by	UCSL Health and Safety Manager	Effective	Immediately
Authorised by:	Chief Executive Officer Contracting

BRIEF DESCRIPTION OF THE ACCIDENT

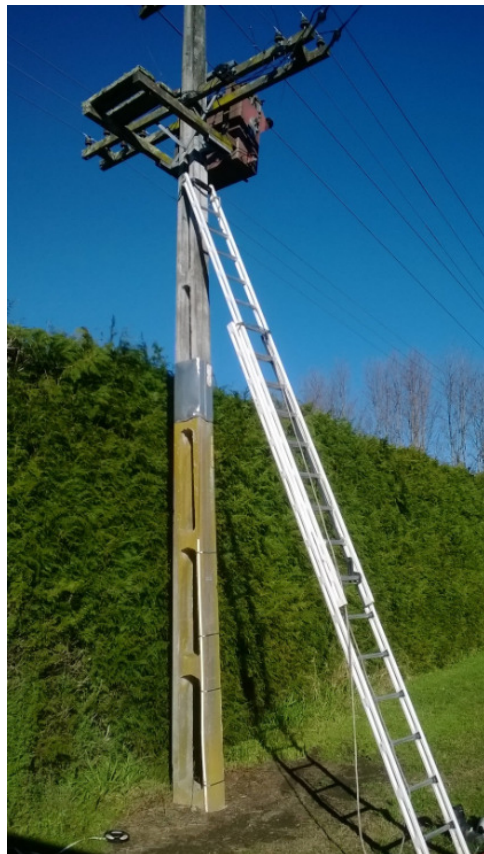
One of the double action clips on his pole strap was not engaged and the staff member subsequently fell to the ground and unfortunately, fractured his pelvis.

Photo 1: The accident scene.

The lineman failed to check both pole strap clips were engaged properly in the harness D-rings before trusting his weight to the pole strap.

- Like all PPE, both pole strap double action clips and harness D-rings must be checked to ensure that they are operational prior to climbing the ladder.
- **NEVER** assume that the pole strap clip that is semi or permanently engaged to your harness D-ring is engaged.
- Once you have climbed the ladder and before **any** weight is placed on the harness and pole strap:
 - Visually check that **both** pole strap double action clips are engaged in your harness D-Rings with the latch outwards.
 - Give **both** clips a tug to check that they are engaged properly.
 - Grab **both** sides of the pole strap and lean back.
- Secure the ladder.
