## Safety Alert

### Near Miss –Ladder drop from tower structure

Date of issue: 21.03.14

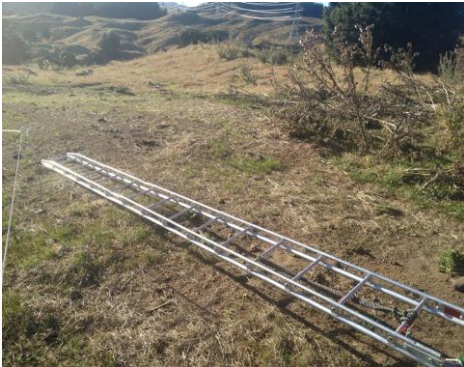
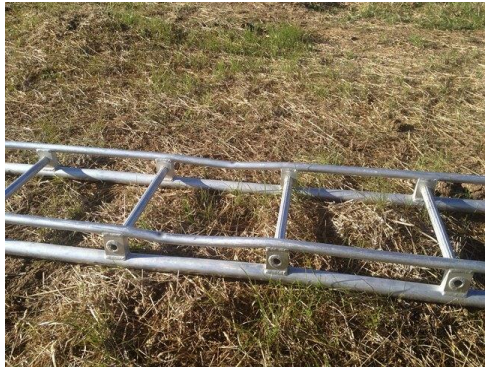
| Incident | Description |
|---|---|
| <i>Event Description</i> | <p><b>Overview:</b><br/>On the 3<sup>rd</sup> March a Northpower Linesman dropped a ladder while attempting to manually transfer the ladder from the top crossarm to the middle crossarm of a tower. The ladder dropped on the ground within the drop zone. There was no injury to any employee and the ladder sustained damage and was removed from service for assessment and repair.</p> <p><b>Just prior to the incident:</b><br/>All the rigging gear was being lowered from the top arm to the middle arm to reposition the equipment, and while still supported by the hand-line the rigging gear was attached to the working point of the middle arm. It was then realised that they could not release the hand line from the rigging equipment without the ladder because it was positioned well below the arm hence the decision to manually lower the ladder.</p> <div> </div> |

| Incident | Description |
|---|---|
| <i>Initial Actions Taken</i> | The ladder was inspected and the damage considered minor and the work continued. |
| <i>Message</i> | <p><b>Lessons to be taken from this:</b></p> <p>First and foremost any damage to a ladder must be removed from service for assessment and repair by someone qualified to determine the extent of the damage.</p> <p>Manual handling alone is not an acceptable practice and the procedure must be updated to reflect this.</p> <p><b>Secure tools and equipment to avoid dangerous drops from heights</b></p> |
