QUALITY ALERT!

04 December 2020
Maximo REF No. 129215

Cable Prep Caused Alarm + 33kV SF6 CB Lockout

Quality Alert REF No : 2020-013

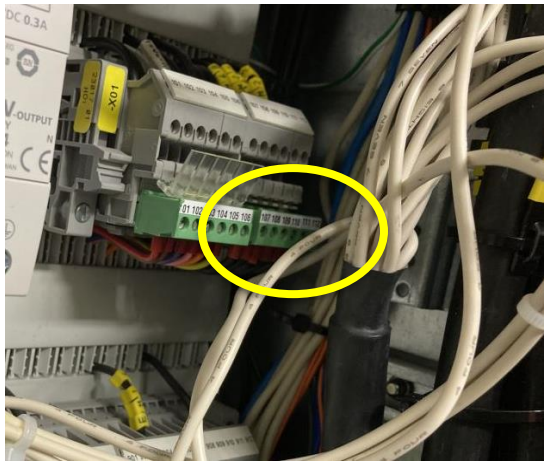
While preparing cores on a cable ahead of a future cutover outage on the PRM RTU replacement, it appears an ILIS plastic fibre connection and an IDIS Phoenix connector were disturbed resulting in an activation of an arc flash and SF6 lock out alarm.

The staff member was not aware he had disturbed the connections as they did not fall out or appear to be loose. There was no recognizable moment that indicated equipment had been disturbed.

- Choice of cable routes.
- Sensitivity of ILIS fibres. ILIS fibre cables use a self-checking light signal. If a cable is bent or moved, the self-checking signal can be disrupted and this causes an alarm.
- Sensitivity of Phoenix terminal contacts.

- Communication of event.
- Toolbox: how far to go regarding preparation and what should wait until the outage.
  known risky and sensitive connections.
  alternative preparation options.
